PRESERVATION MARYLAND

INVITATION TO BID

Williams Schoolhouse Phase II Restoration

Attachment B

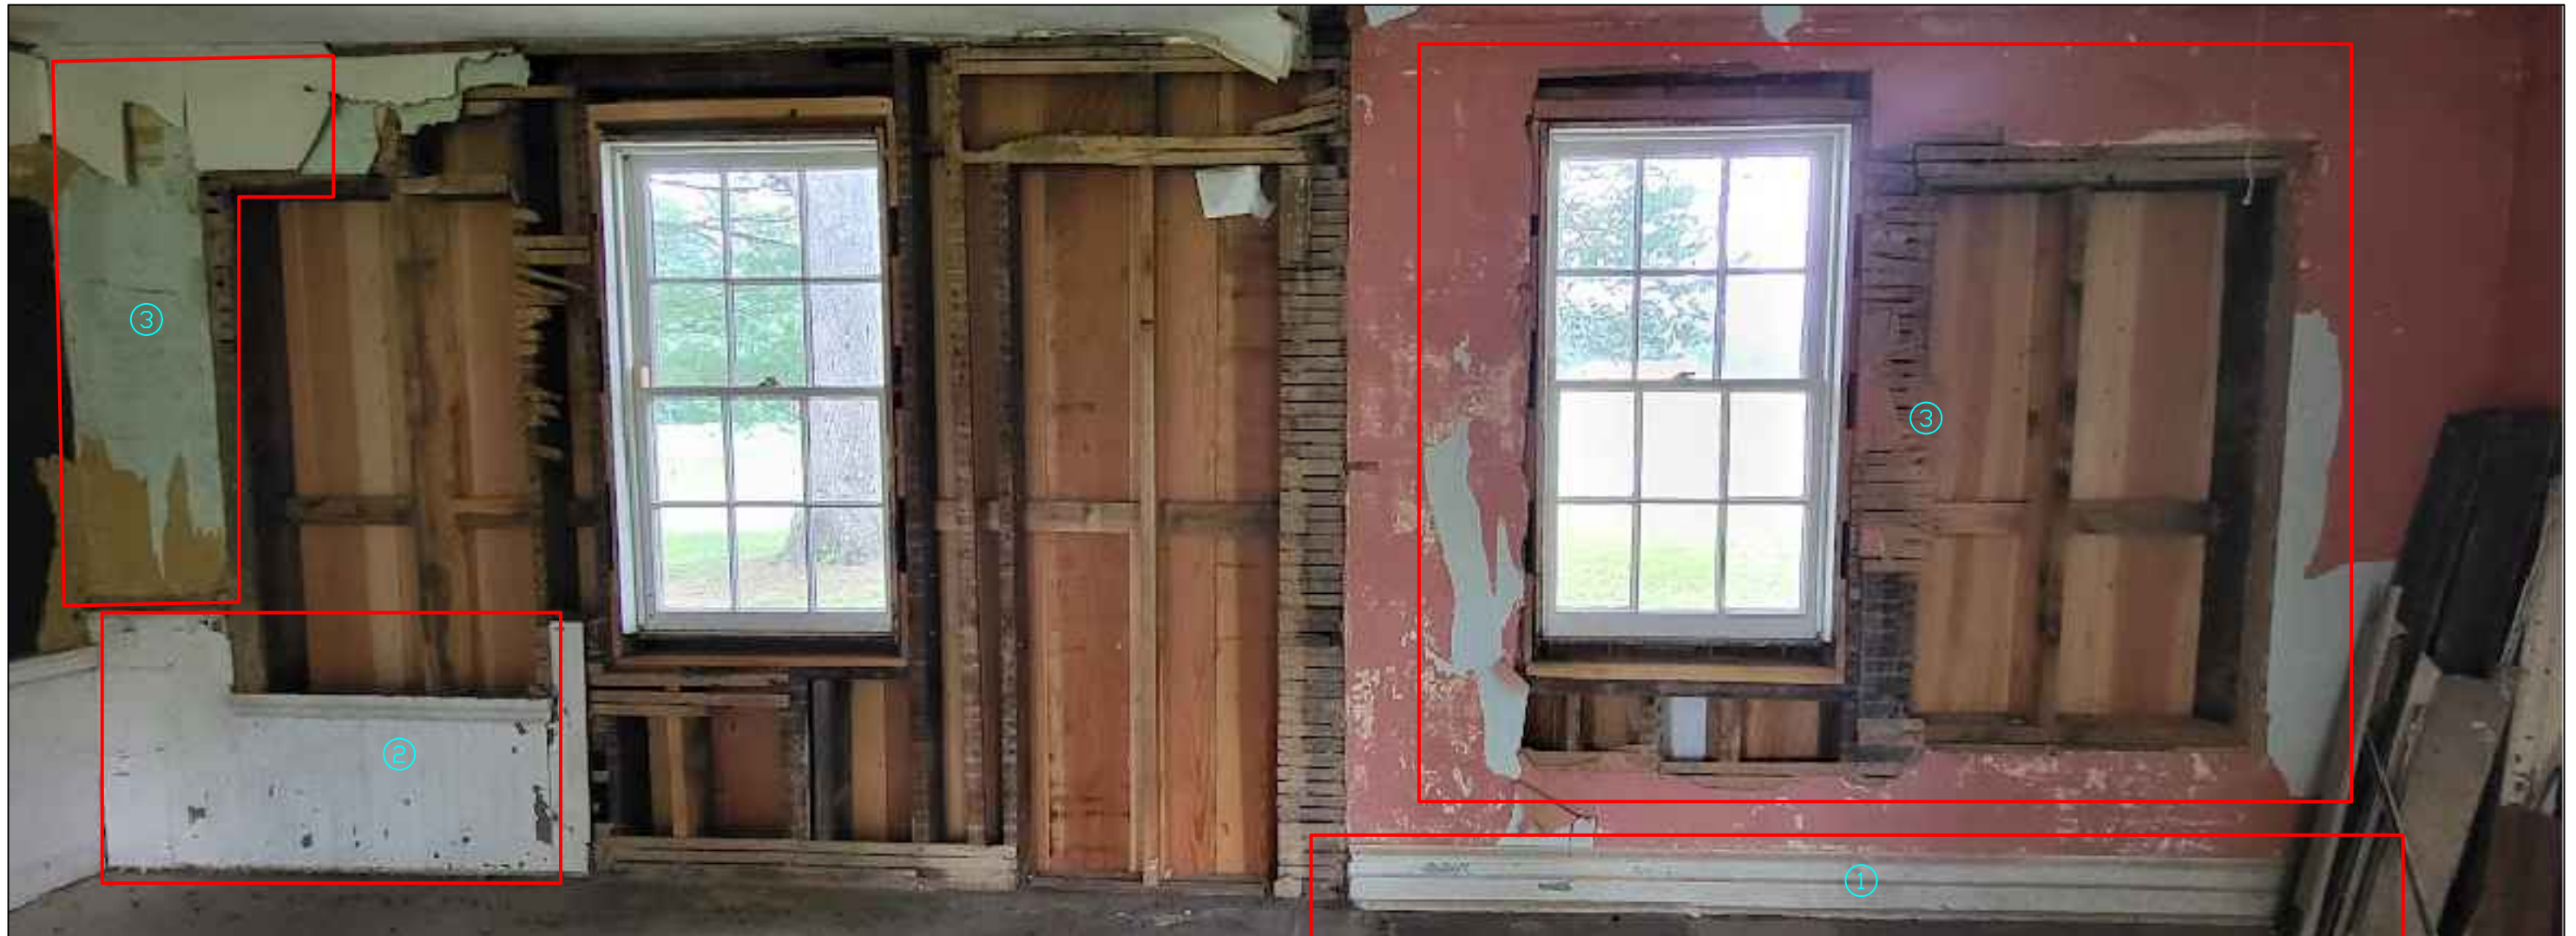
SHEET 1 OF 10

DEMOLITION KEY NOTES:

- ① EXISTING BASEBOARD TO BE REMOVED.
- ② REMOVE CUT DOWN BEADBOARD DADO. RETAIN FULL LENGTH PIECES.
- ③ REMOVE WALLPAPER. STABILIZE OR DEMOLISH FAILED PLASTER AS NEEDED. SOUND PLASTER TO REMAIN

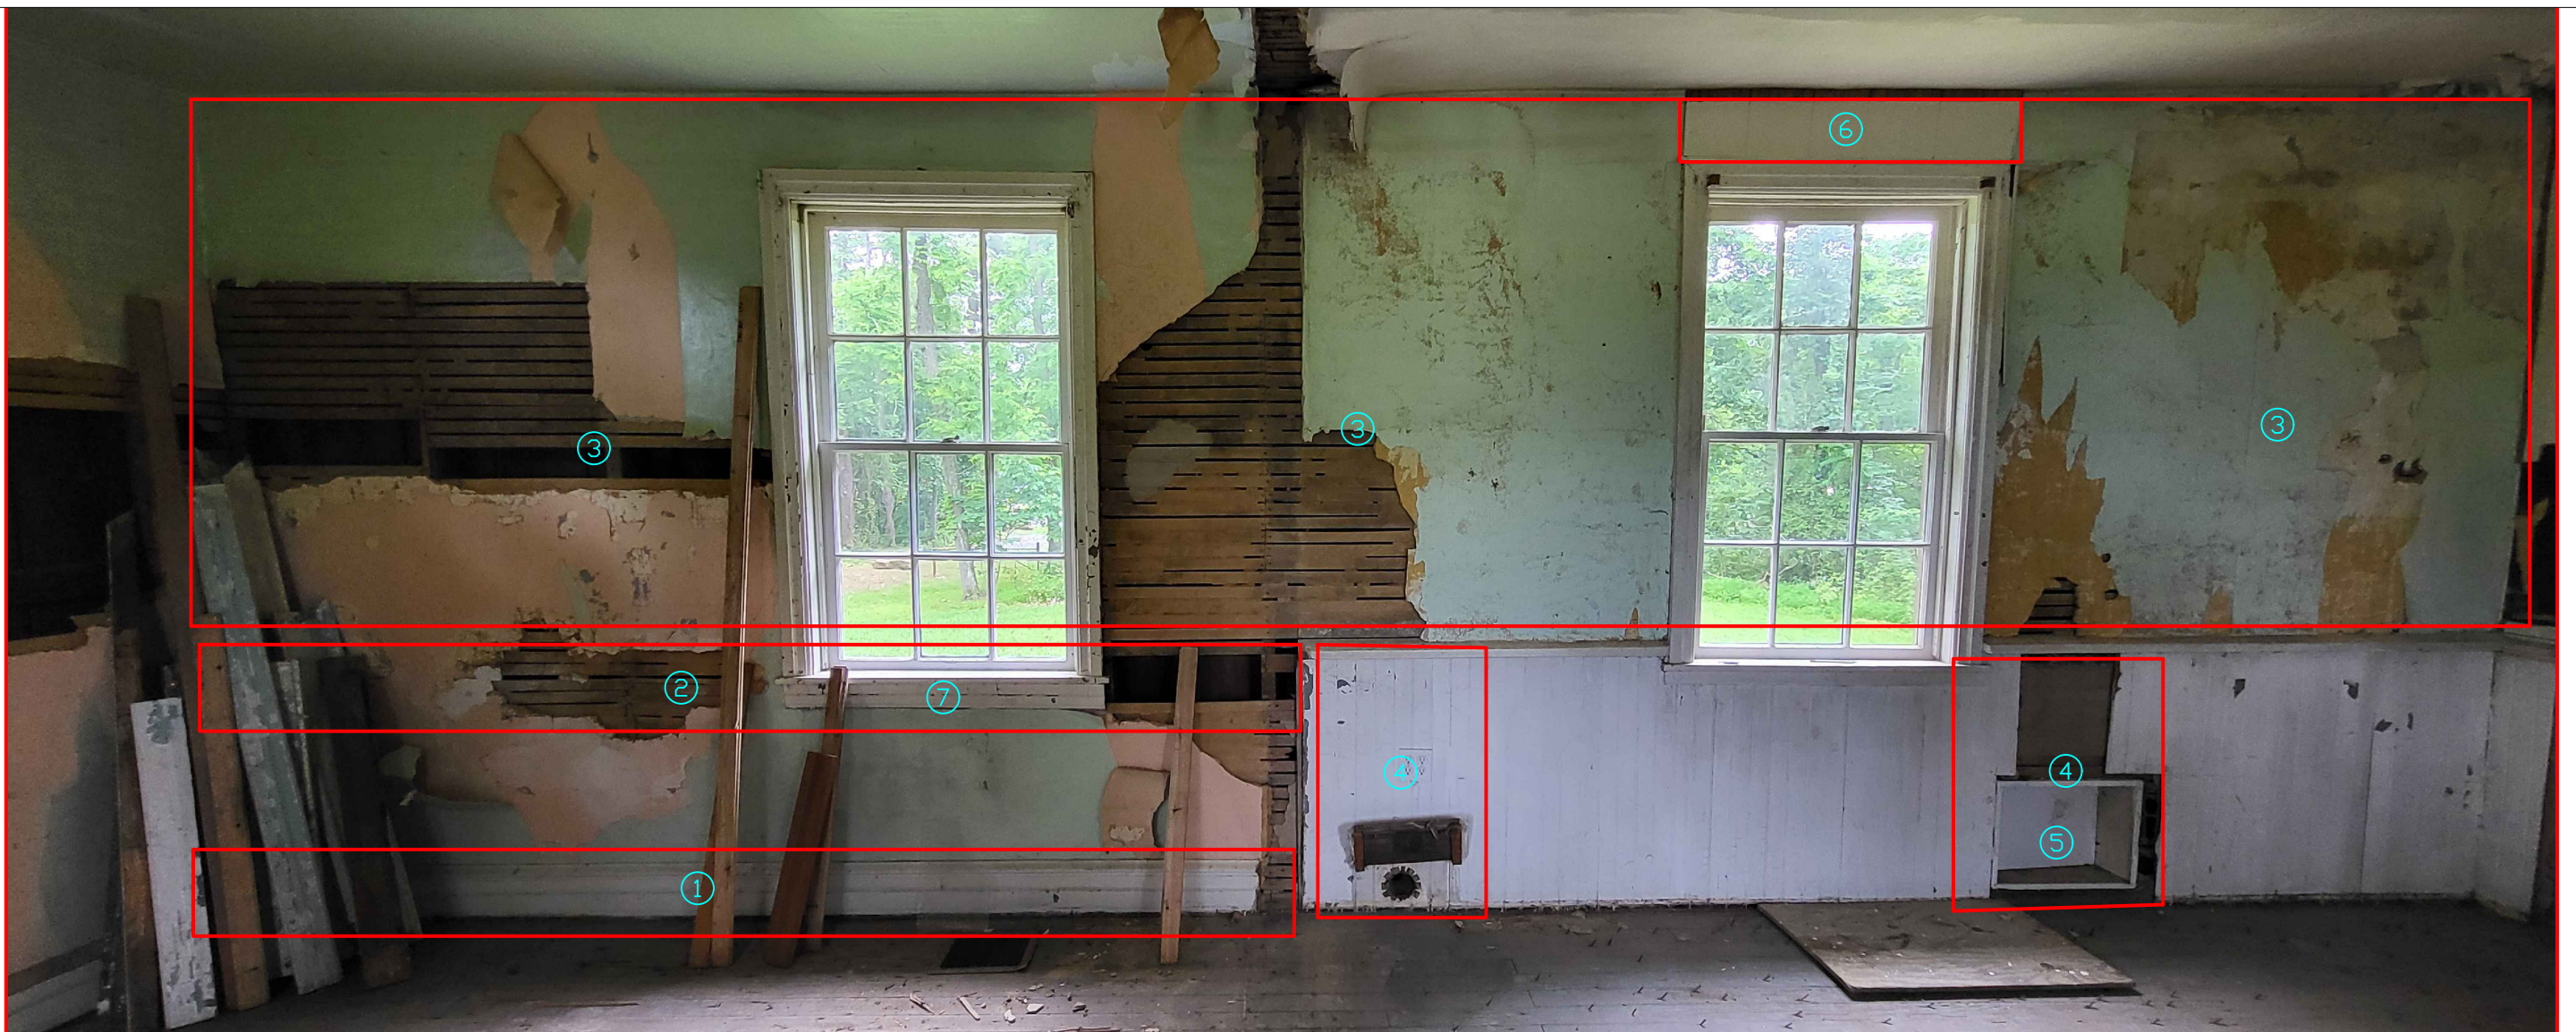
Date: 6/25/2026
 Drawing Number:
A-2
 SHEET 2 OF 10

DEMOLITION KEY NOTES:

- ① EXISTING BASEBOARD TO BE REMOVED.
- ② CUT AND REMOVE PLASTER TO PREPARE FOR DADO NAILER
- ③ REMOVE WALLPAPER. STABILIZE OR DEMOLISH FAILED PLASTER AS NEEDED. SOUND PLASTER TO REMAIN
- ④ REMOVE CUT DOWN BEADBOARD DADO. RETAIN FULL LENGTH PIECES.
- ⑤ REMOVE WOODEN BOX INSERT
- ⑥ REMOVE REMAINING PANELING
- ⑦ REMOVE LATER WINDOW APRON

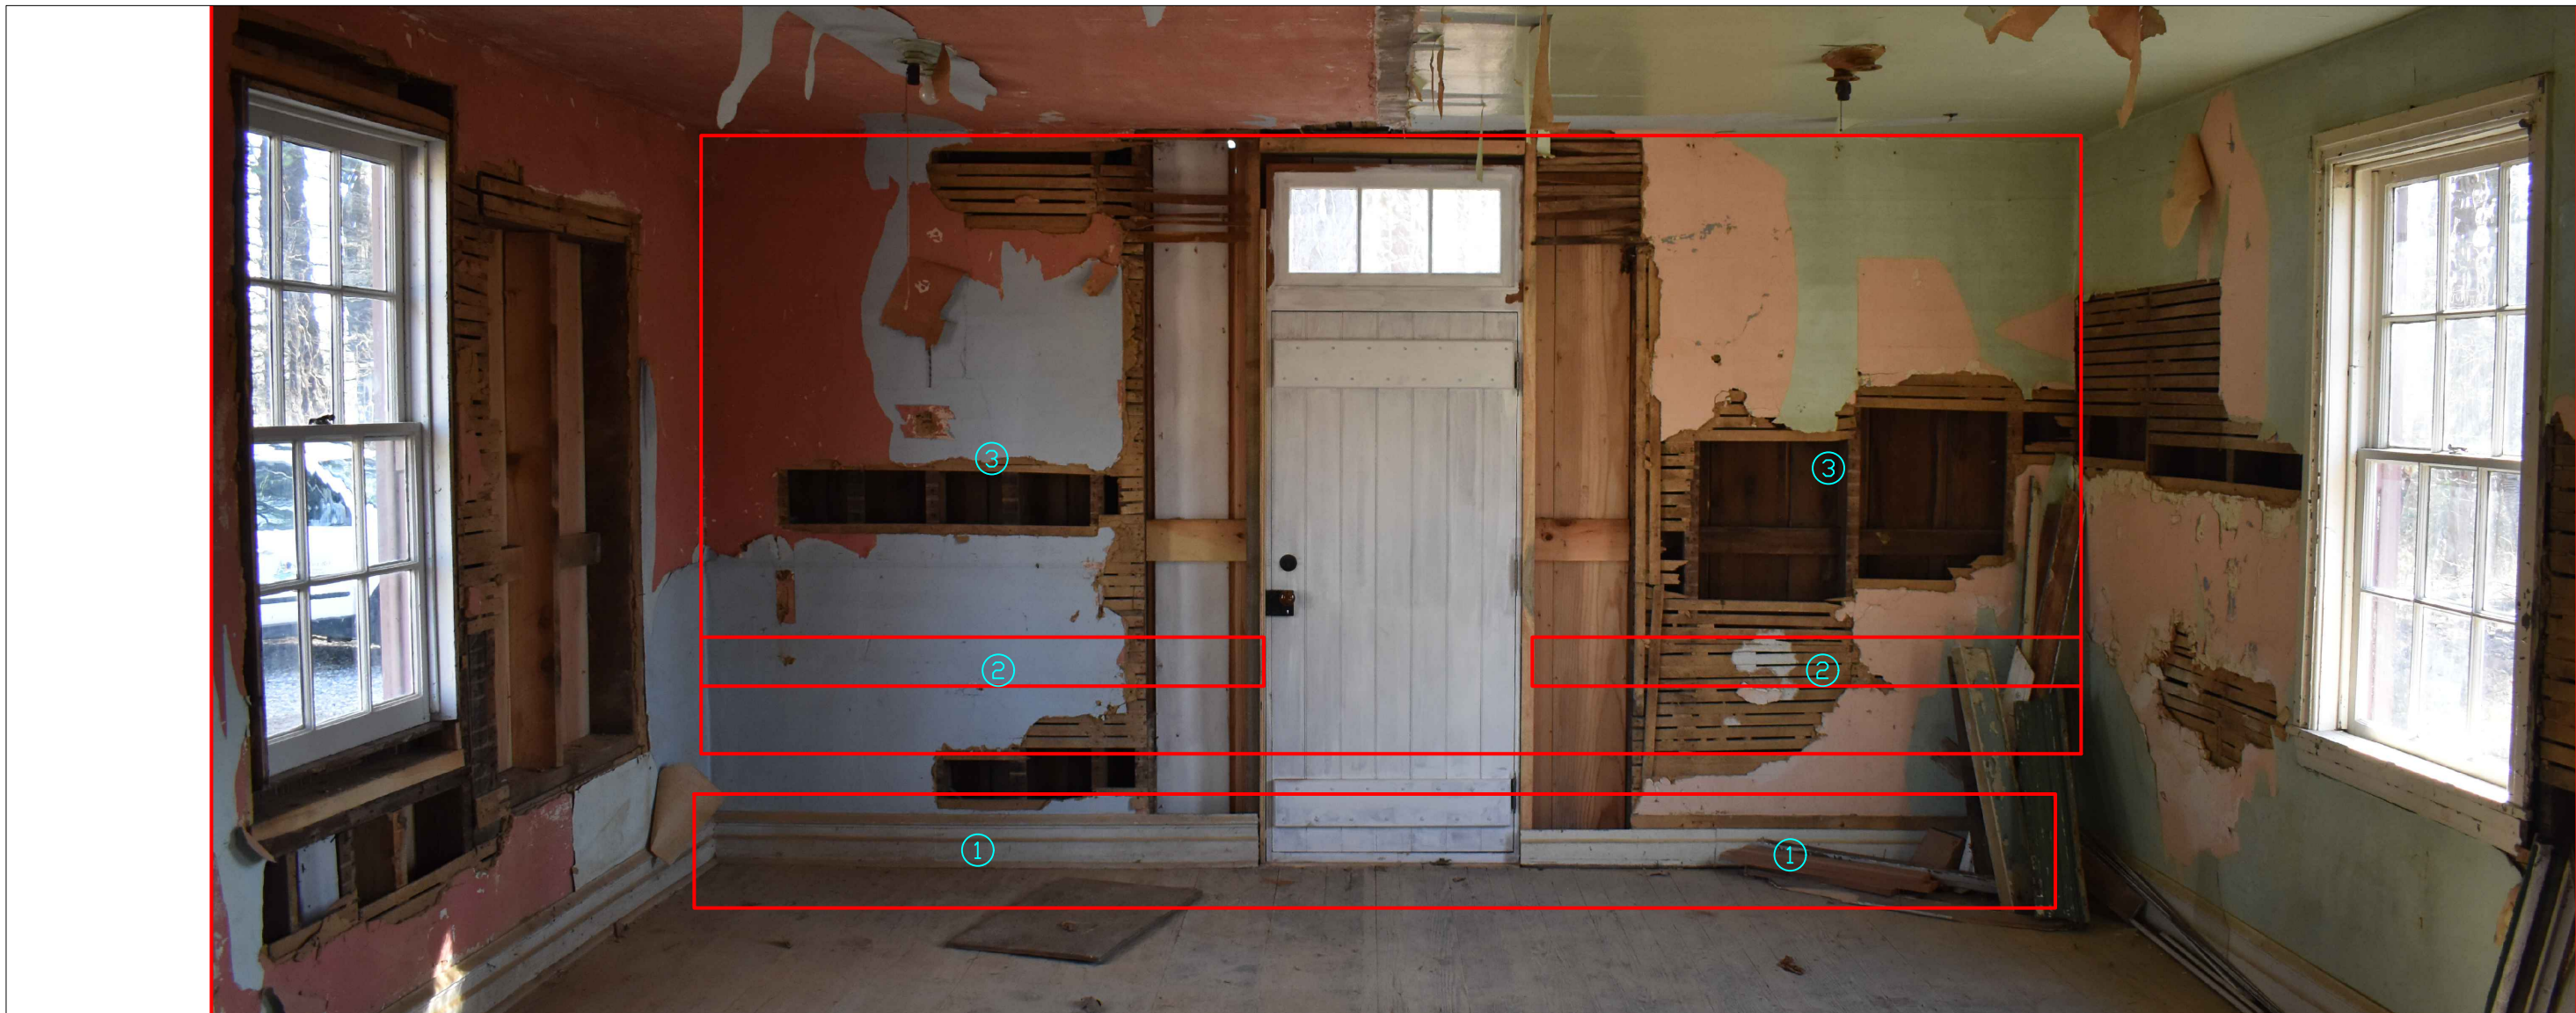
SHEET 3 OF 10

DEMOLITION KEY NOTES:

- ① EXISTING BASEBOARD TO BE REMOVED.
- ② CUT AND REMOVE PLASTER TO PREPARE FOR DADO NAILER
- ③ REMOVE WALLPAPER. STABILIZE OR DEMOLISH FAILED PLASTER AS NEEDED. SOUND PLASTER TO REMAIN

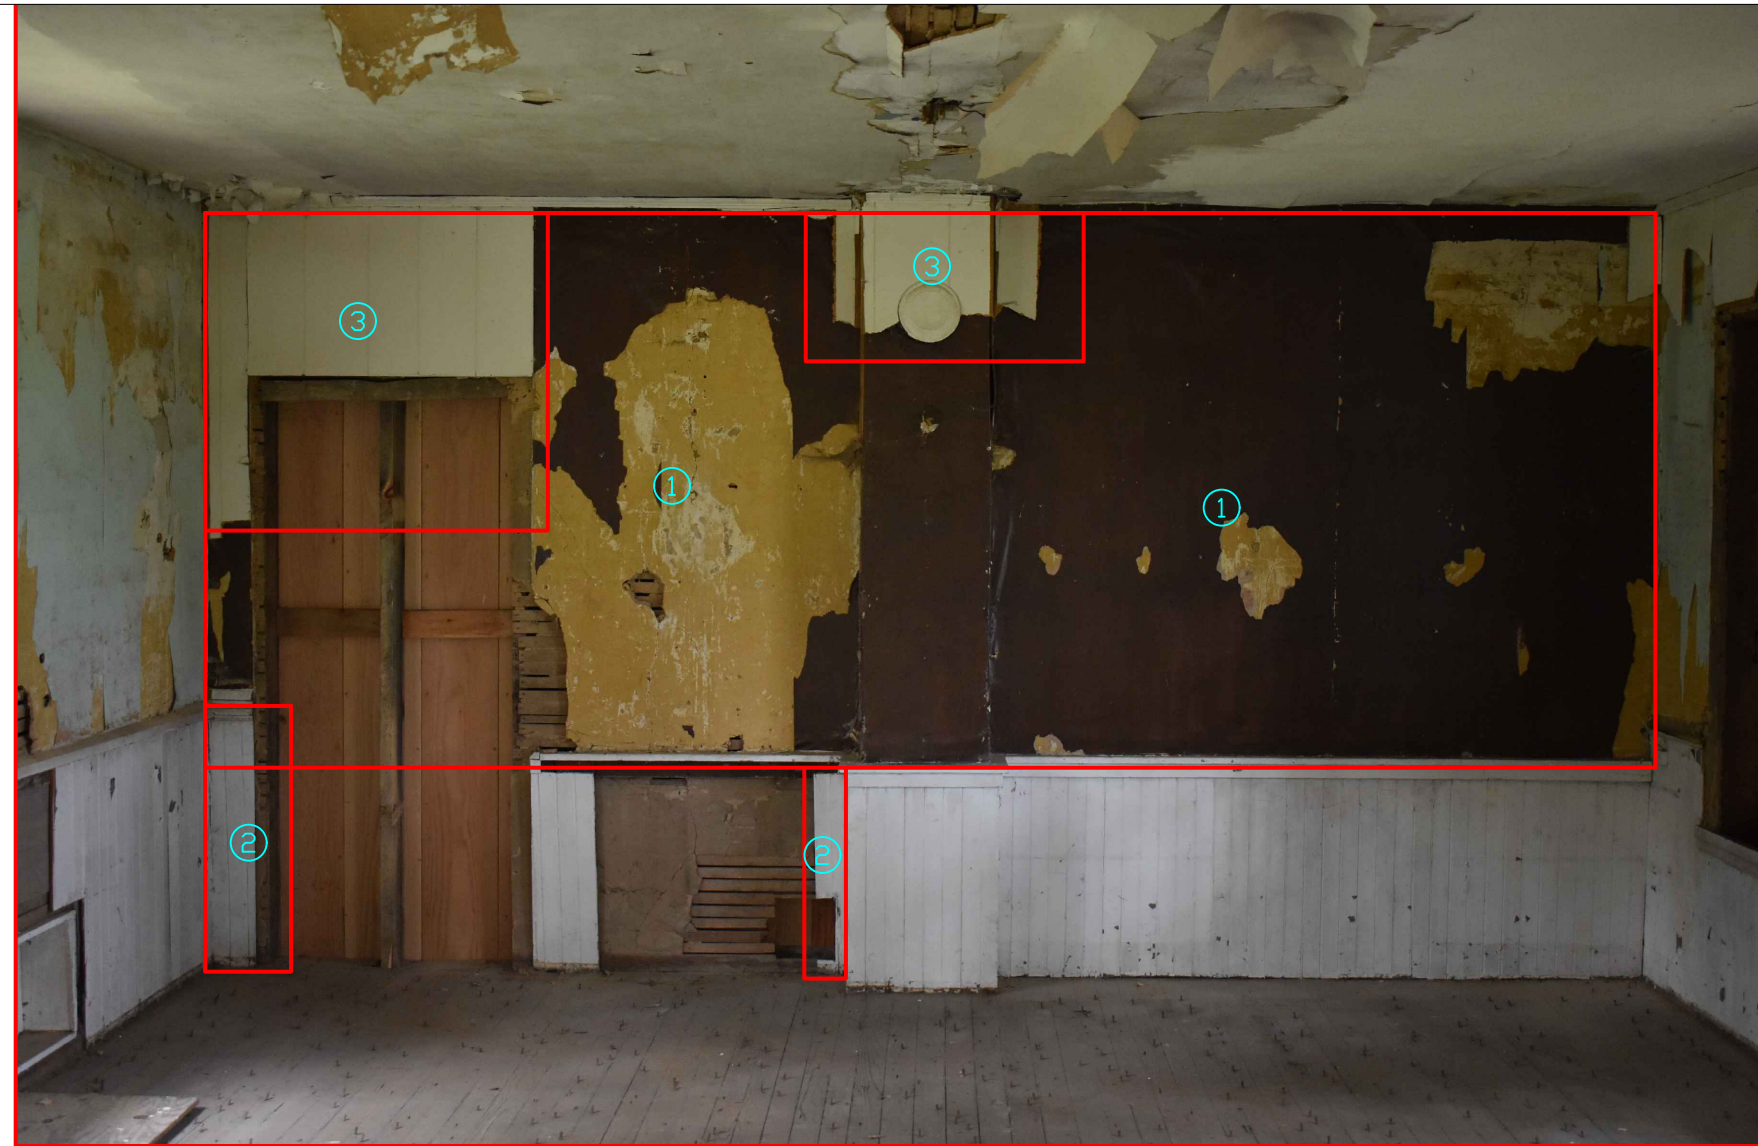
SHEET 4 OF 10

DEMOLITION KEY NOTES:

- ① REMOVE WALLPAPER. STABILIZE OR DEMOLISH FAILED PLASTER AS NEEDED. SOUND PLASTER TO REMAIN
- ② REMOVE BEADBOARD DADO. RETAIN FULL LENGTH PIECES.
- ③ REMOVE REMAINING PANELING

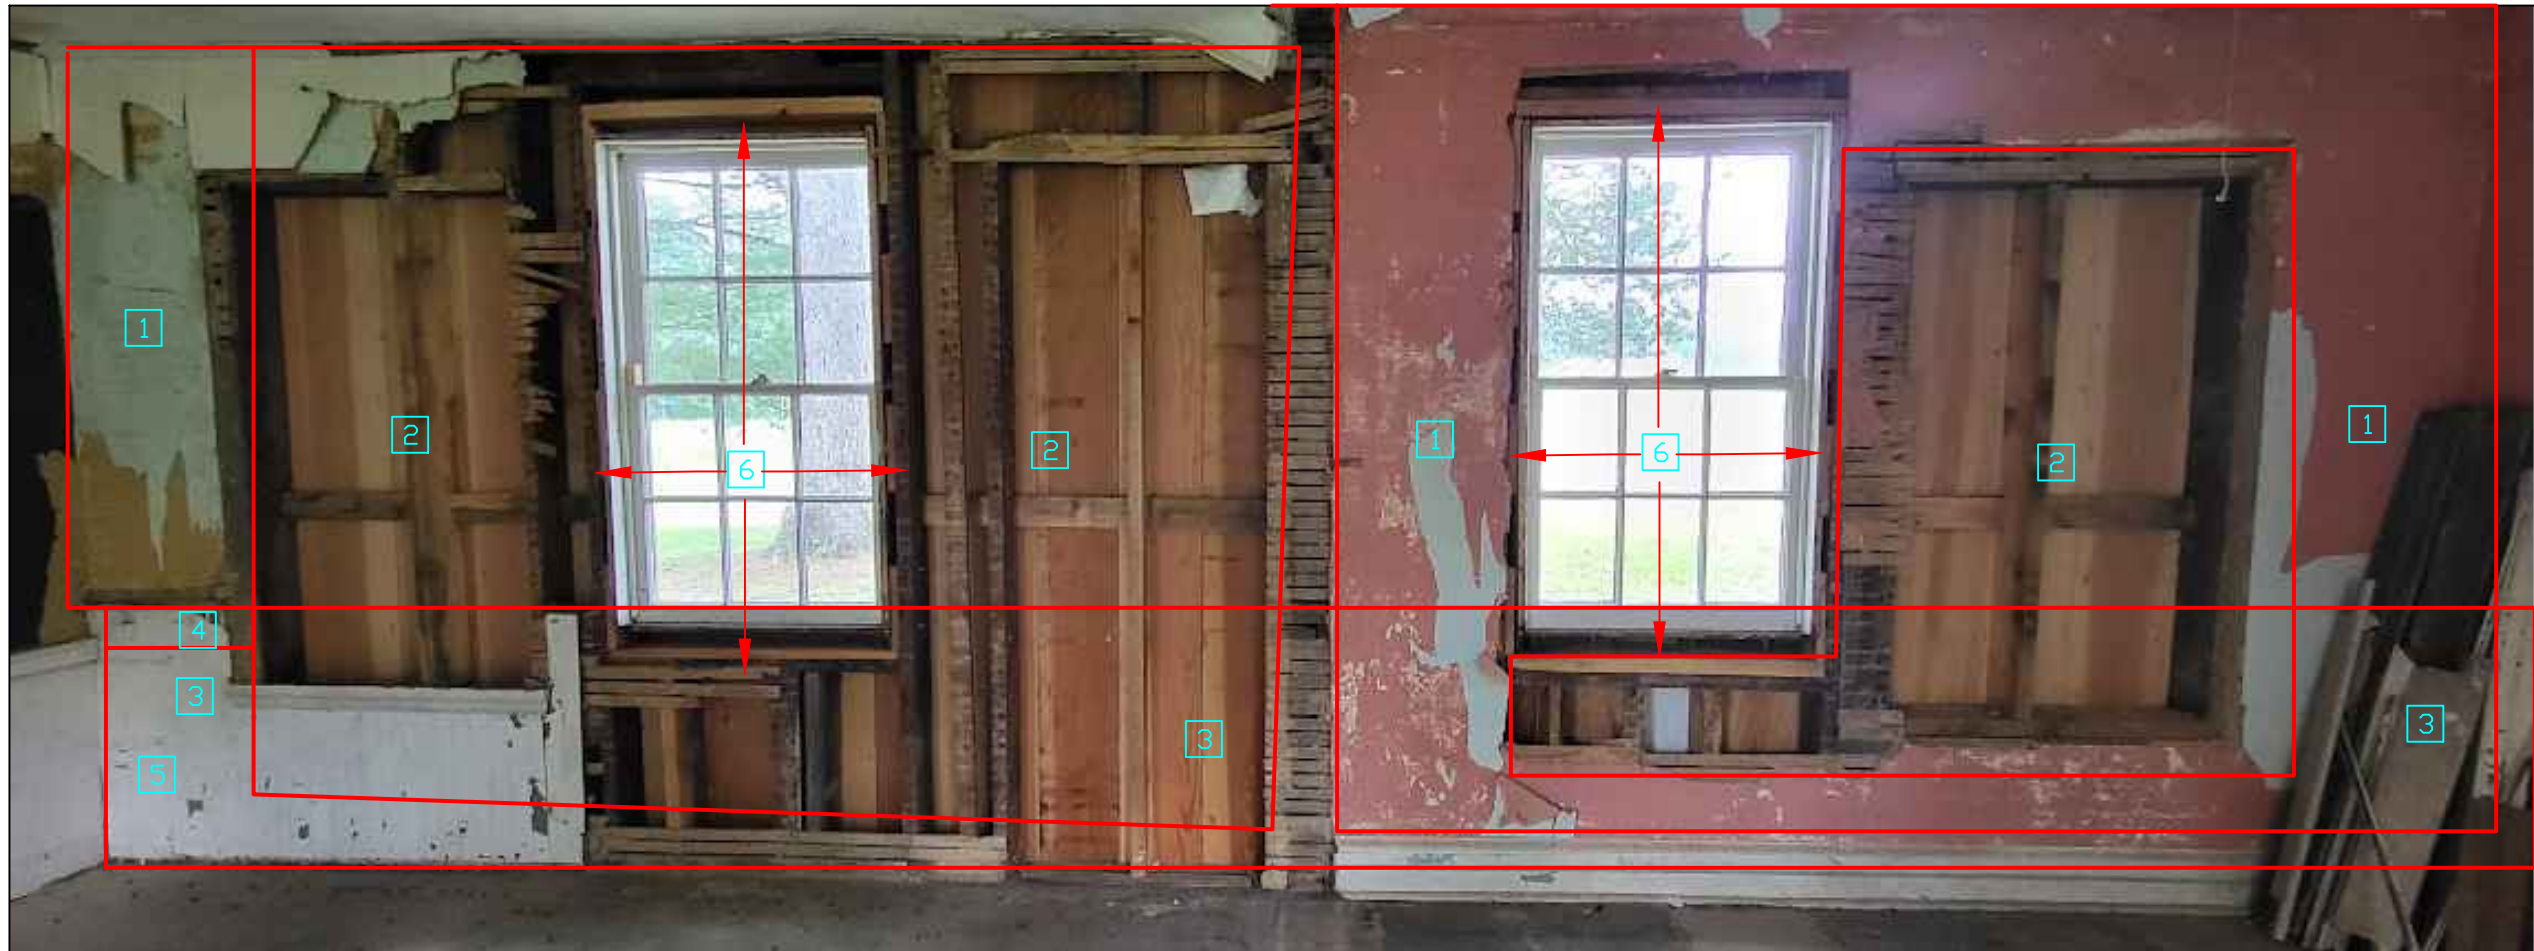
SHEET 5 OF 10

RESTORATION KEY NOTES:

1 REPAIR EXISTING PLASTER AS NEEDED.

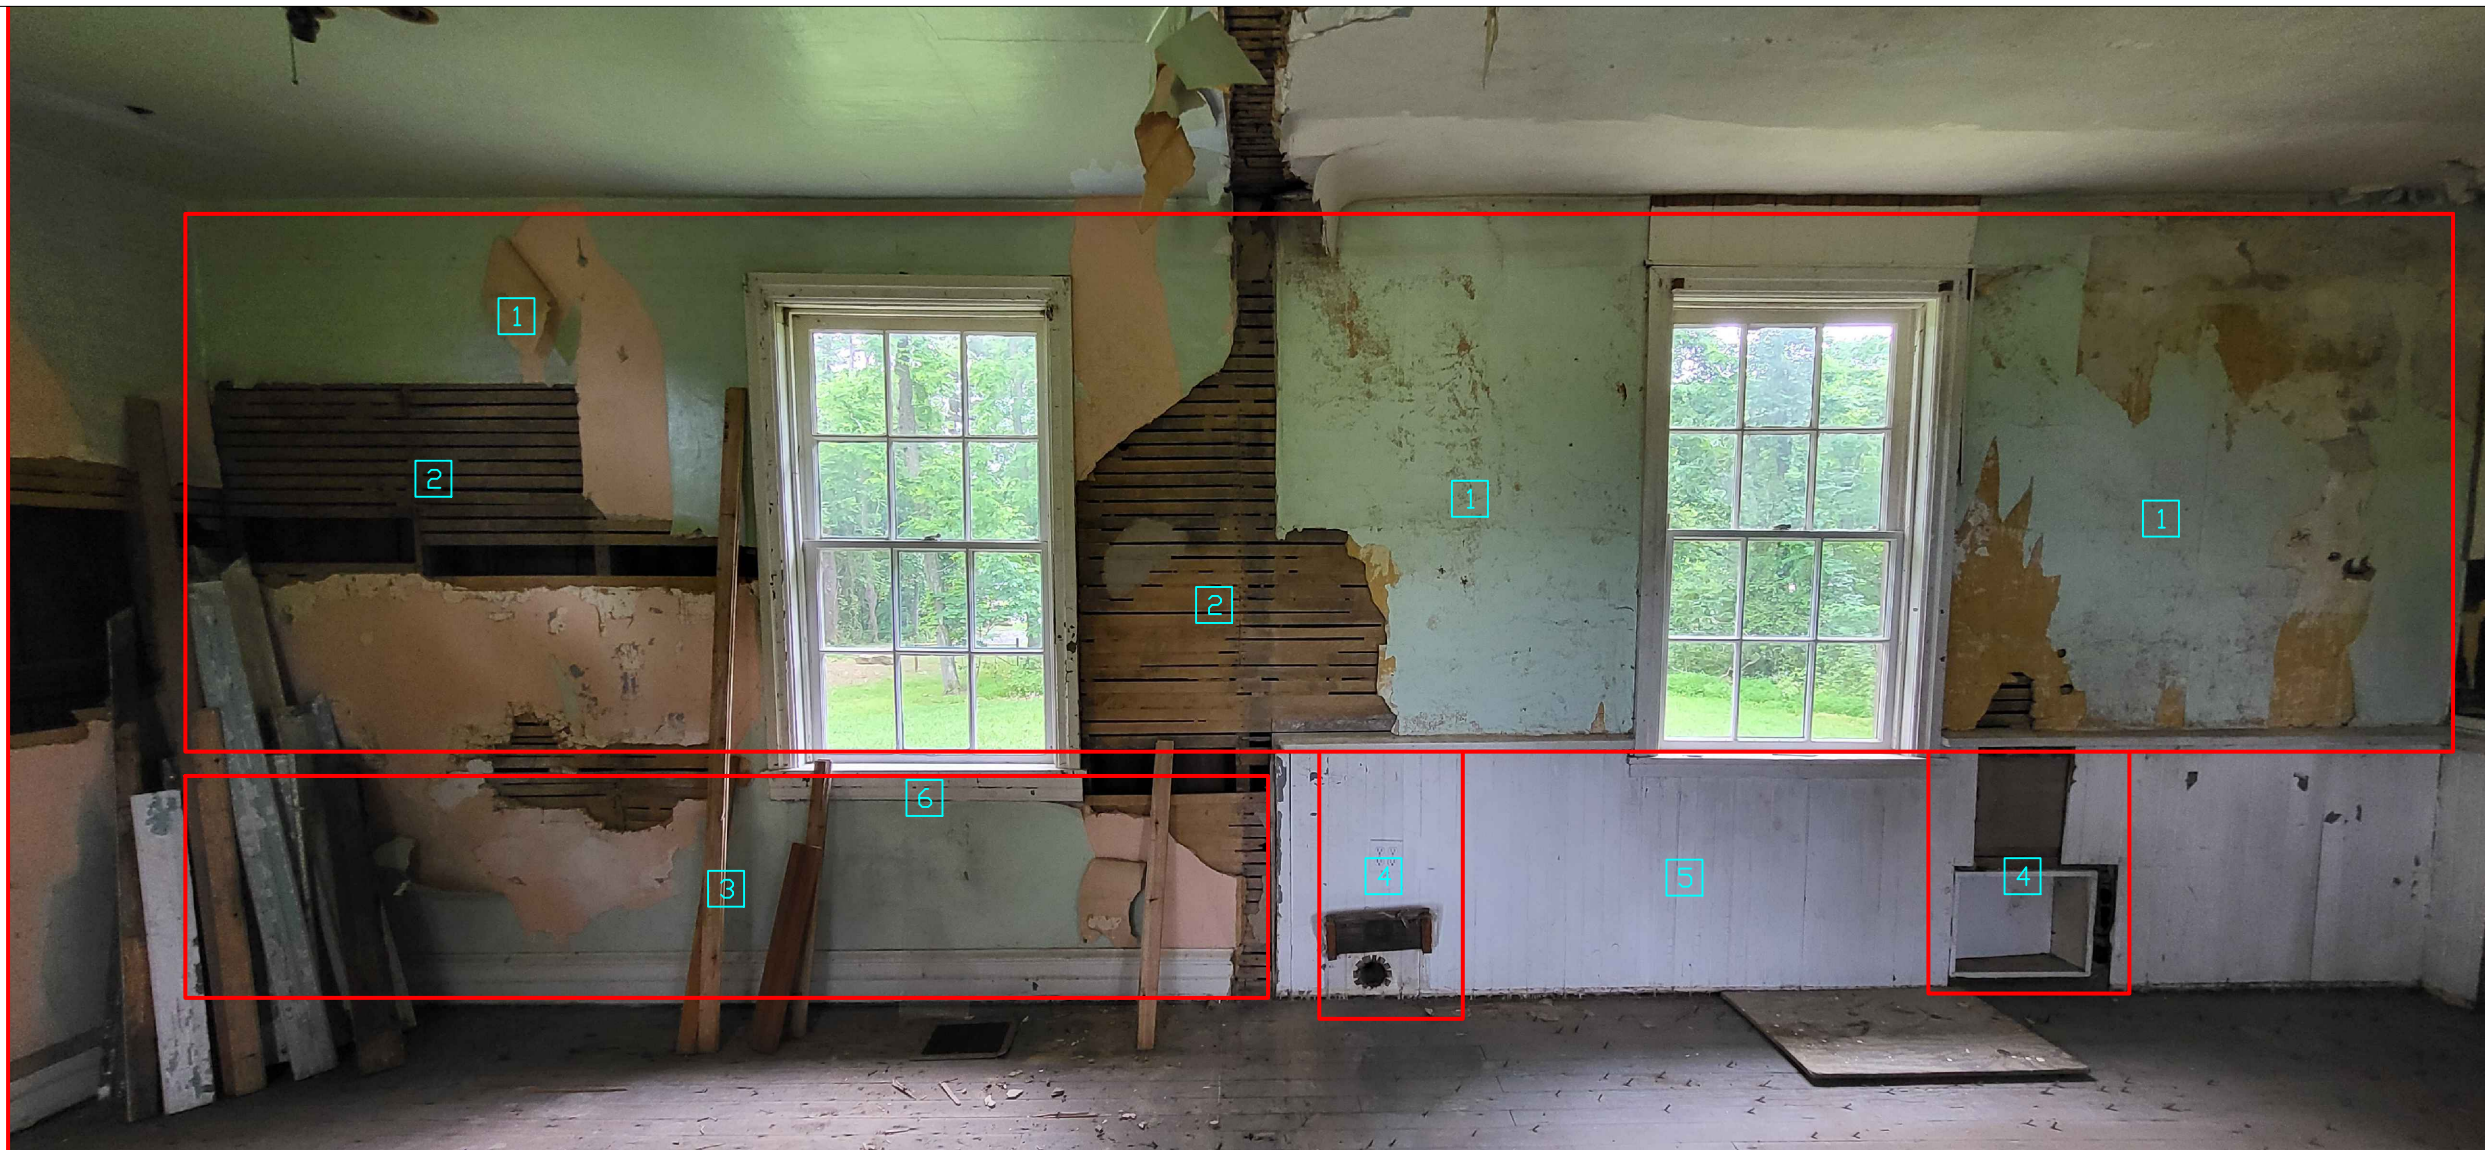
Date: 6/25/2026
 Drawing Number:
A-6
 SHEET 6 OF 10

RESTORATION KEY NOTES:

1 REPAIR EXISTING PLASTER AS NEEDED.

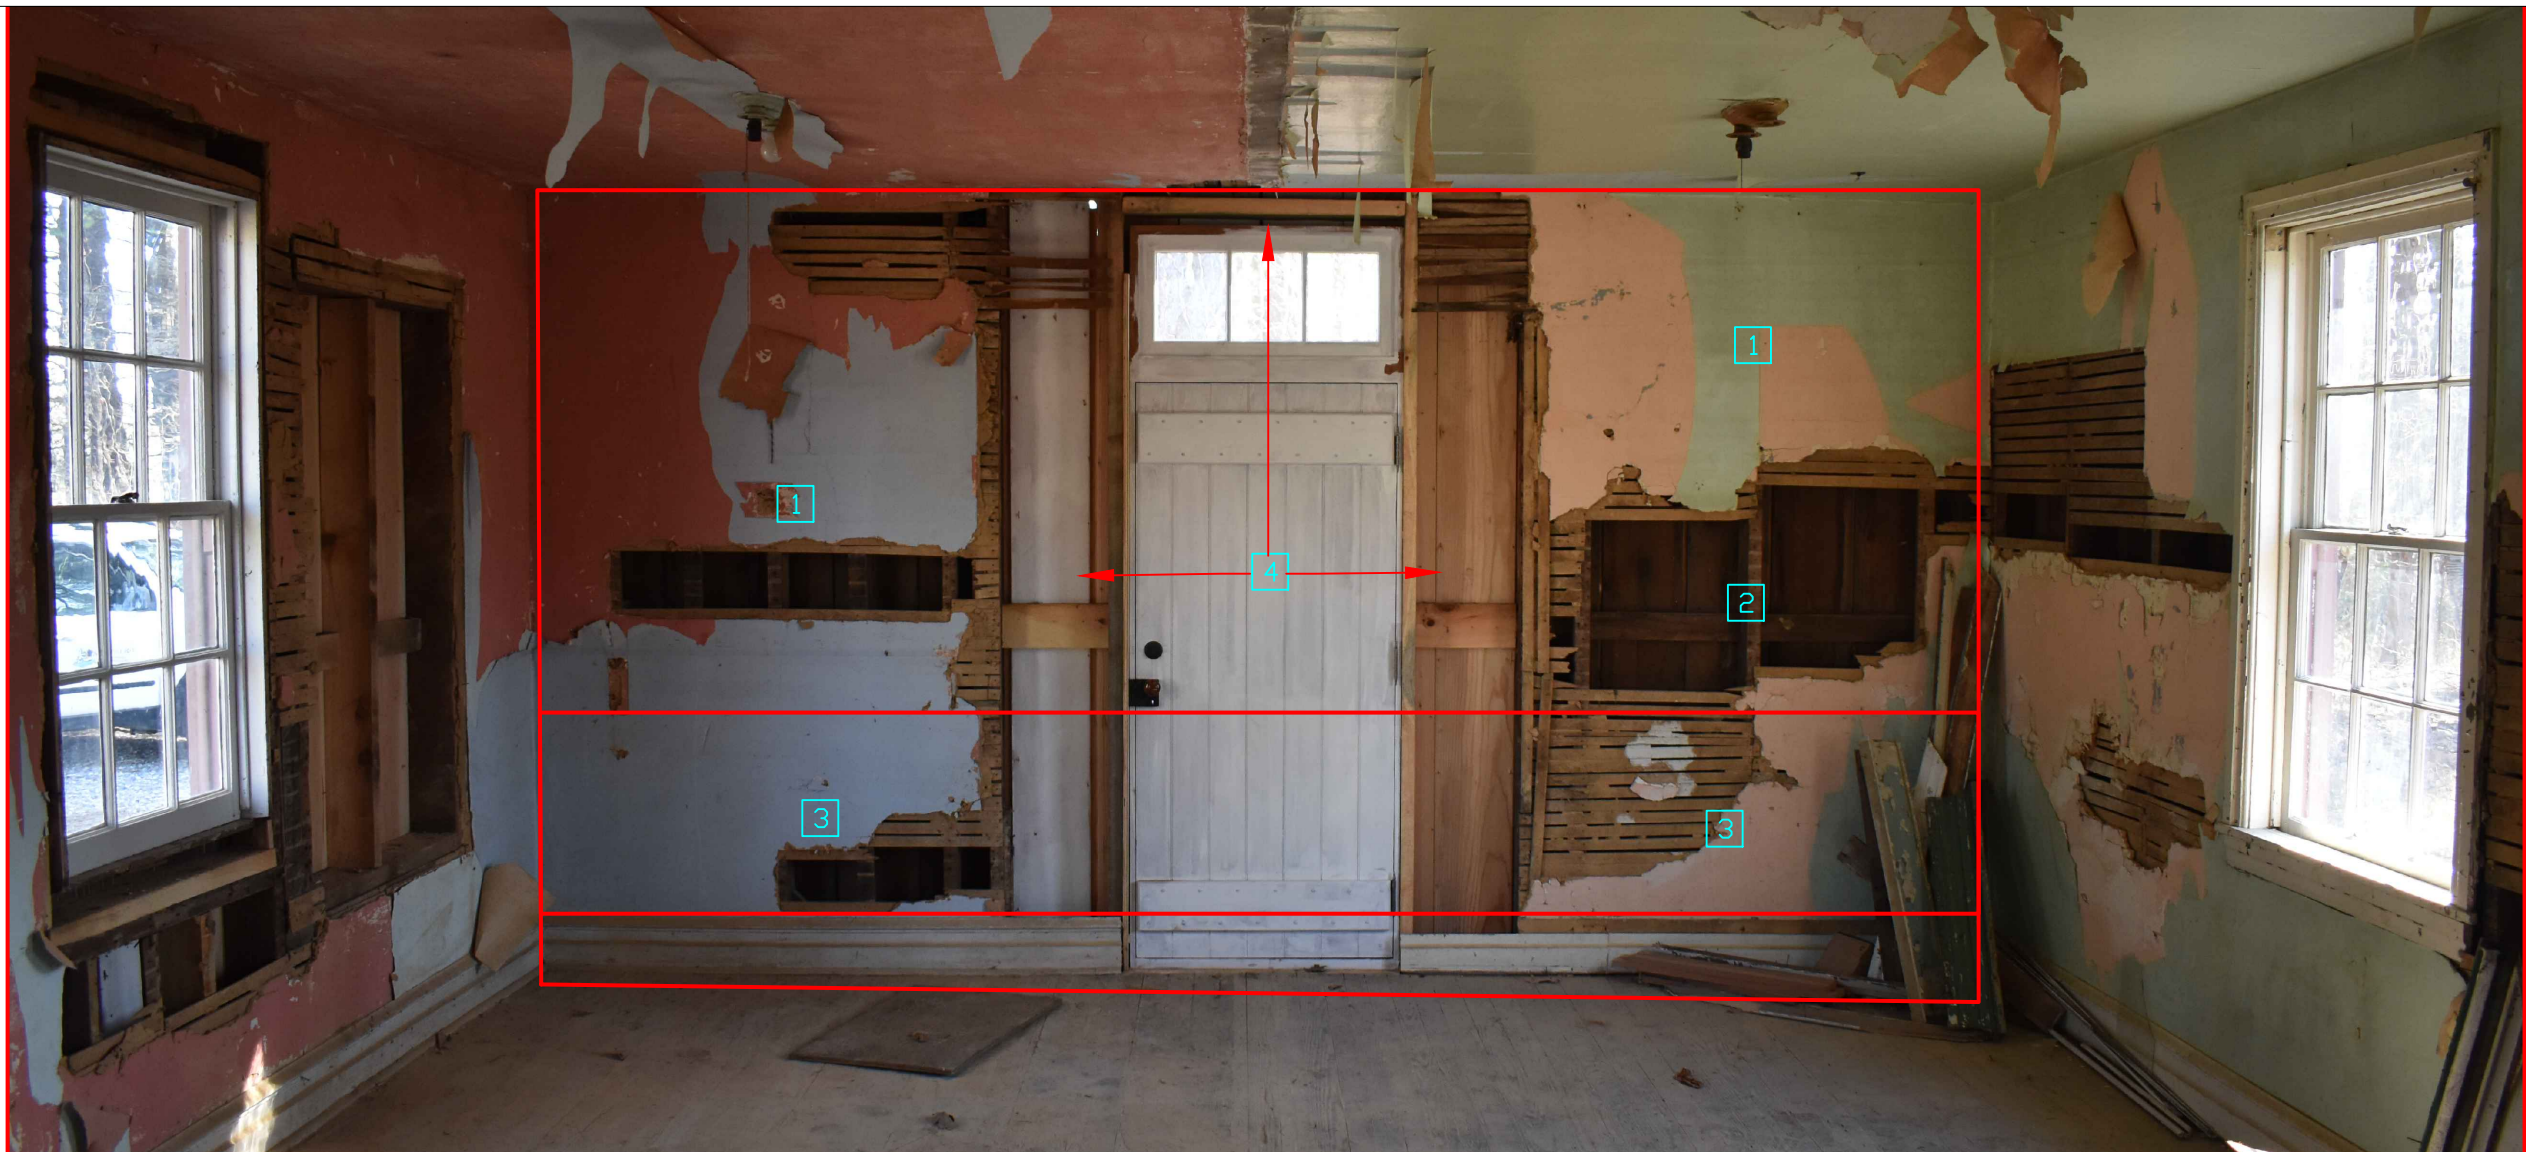
SHEET 7 OF 10

RESTORATION KEY NOTES:

1 REPAIR EXISTING PLASTER AS NEEDED.

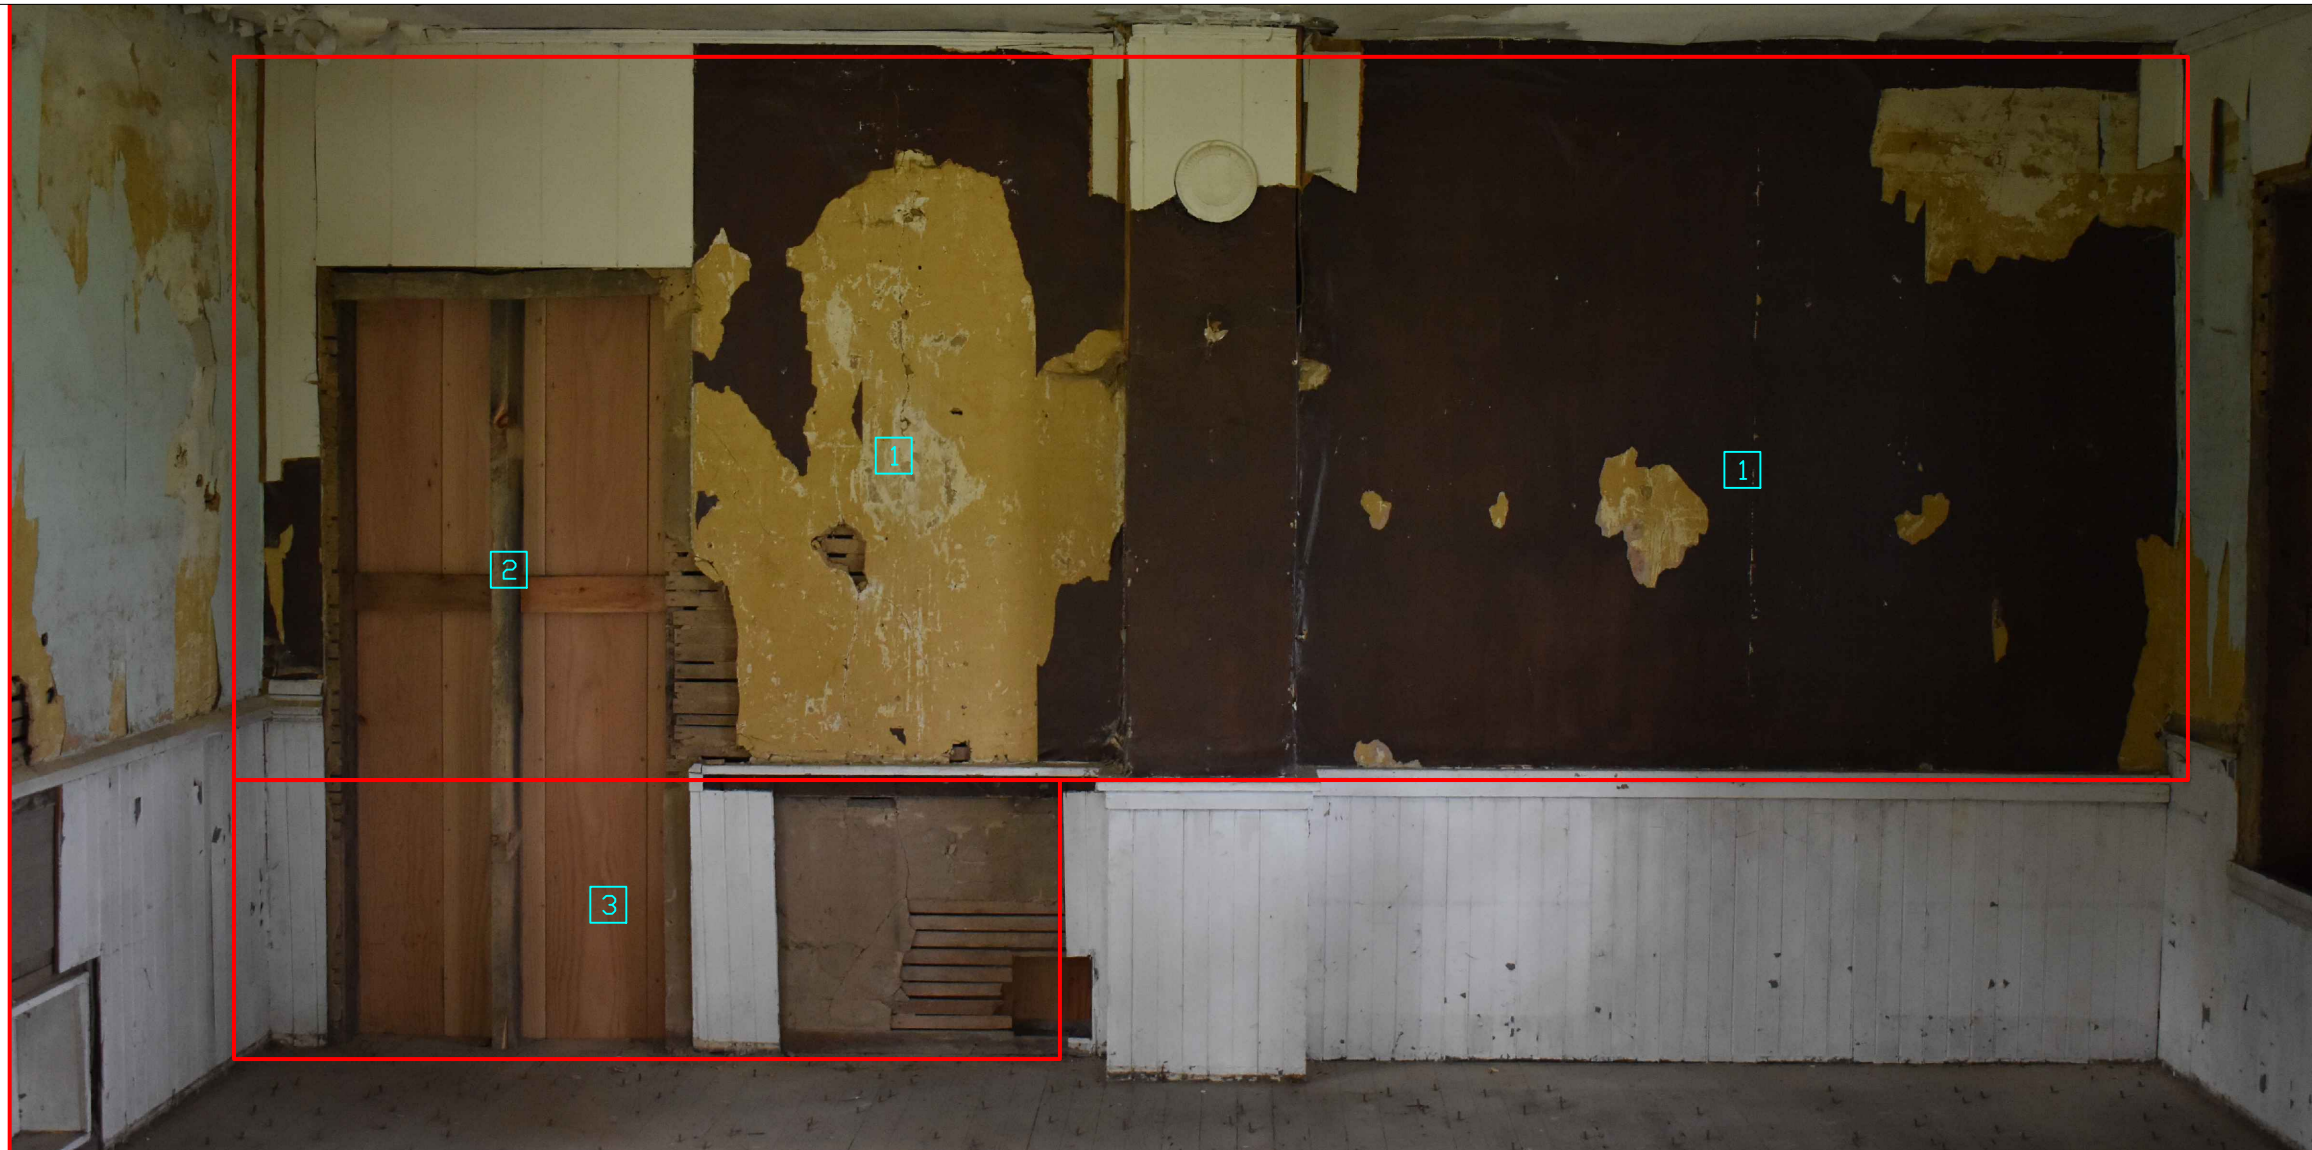
SHEET 8 OF 10

RESTORATION KEY NOTES:

- 1 REPAIR EXISTING PLASTER AS NEEDED.
- 2 INSTALL NEW LATH AND PLASTER
- 3 INSTALL NEW BEAD BOARD DADO AND CAP INCLUDING NECESSARY NAILERS

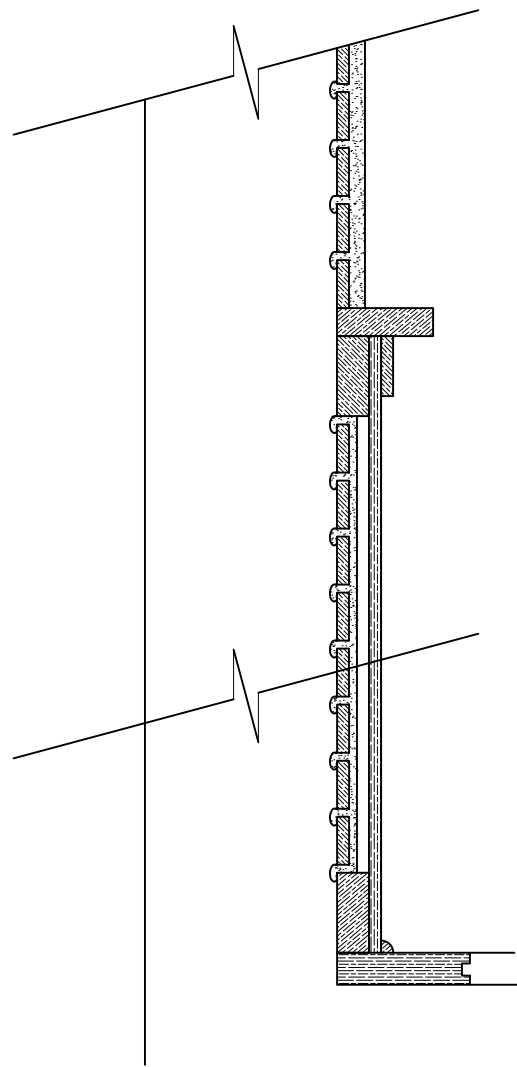
DADO AND CAP FOR WEST WALL

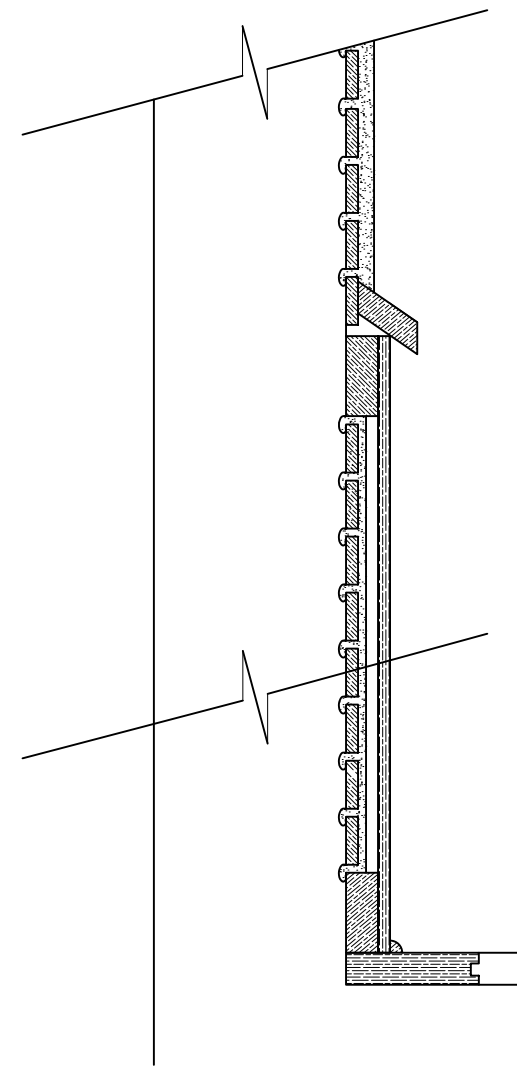
DADO AND CAP FOR NORTH, SOUTH, AND EAST WALLS
