PRESERVATION MARYLAND

INVITATION TO BID

Williams Schoolhouse Phase II Restoration

Attachment B

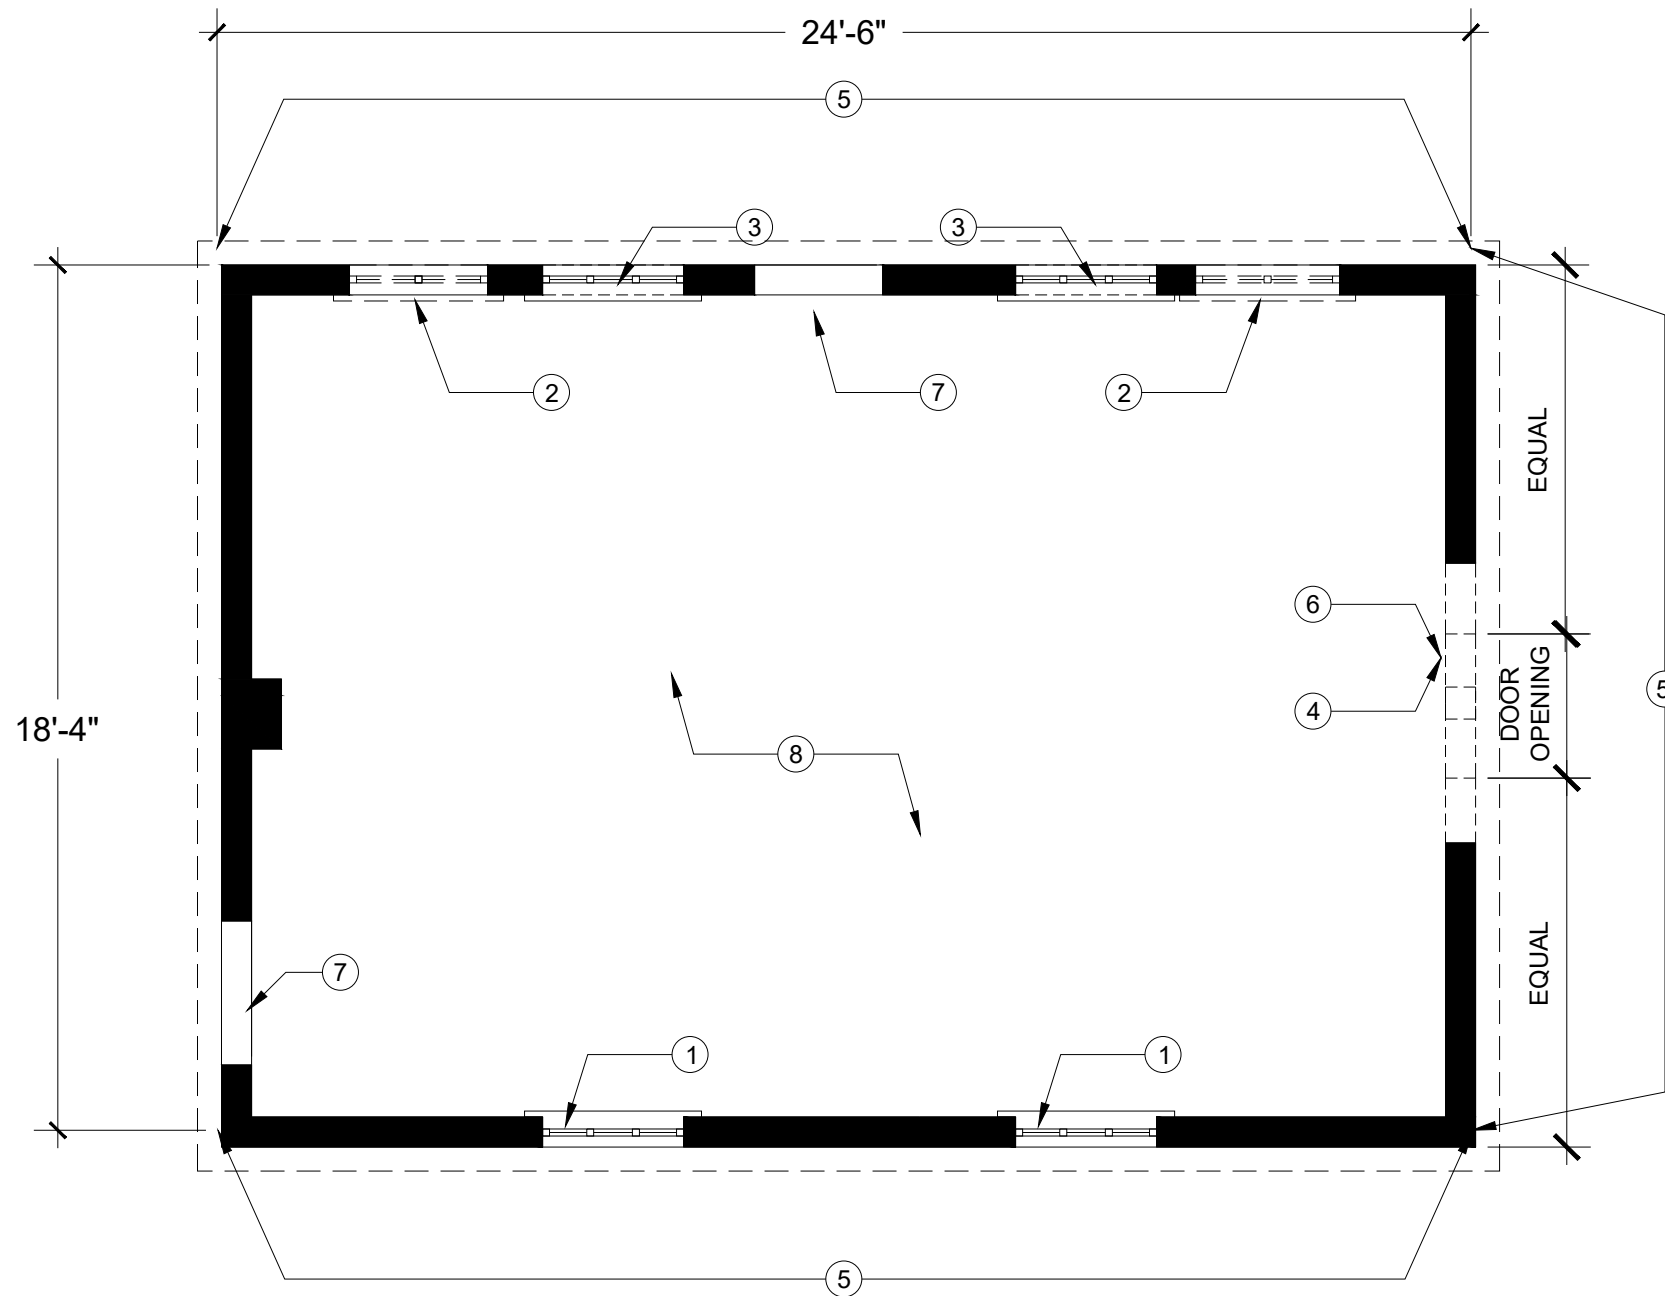
A FLOOR PLAN DEMOLITION
SCALE: 1/4" = 1'-0"

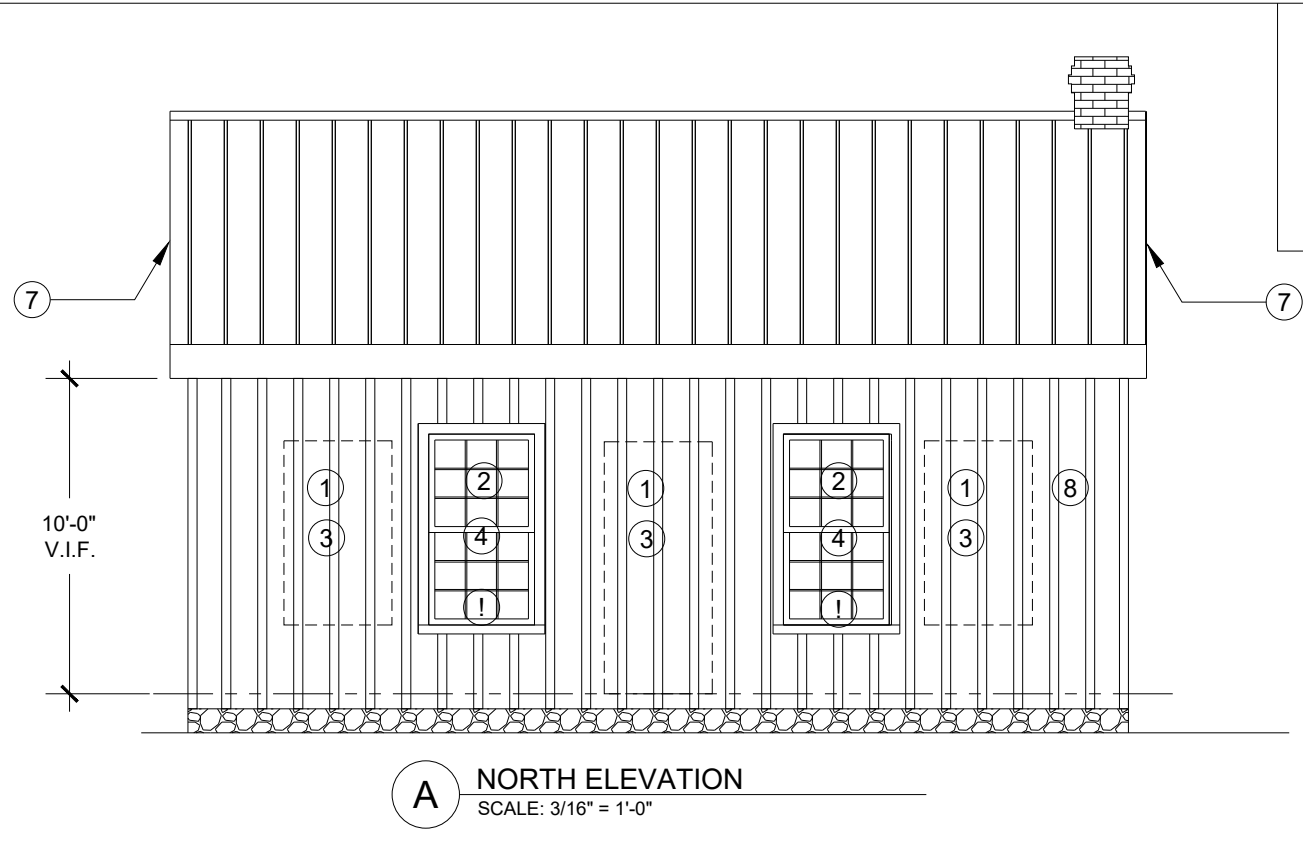
A NORTH ELEVATION
SCALE: 3/16" = 1'-0"

INSTALL 5 EVENLY SPACED SOFFIT VENTS ALONG THE
NORTH & SOUTH ELEVATIONS.

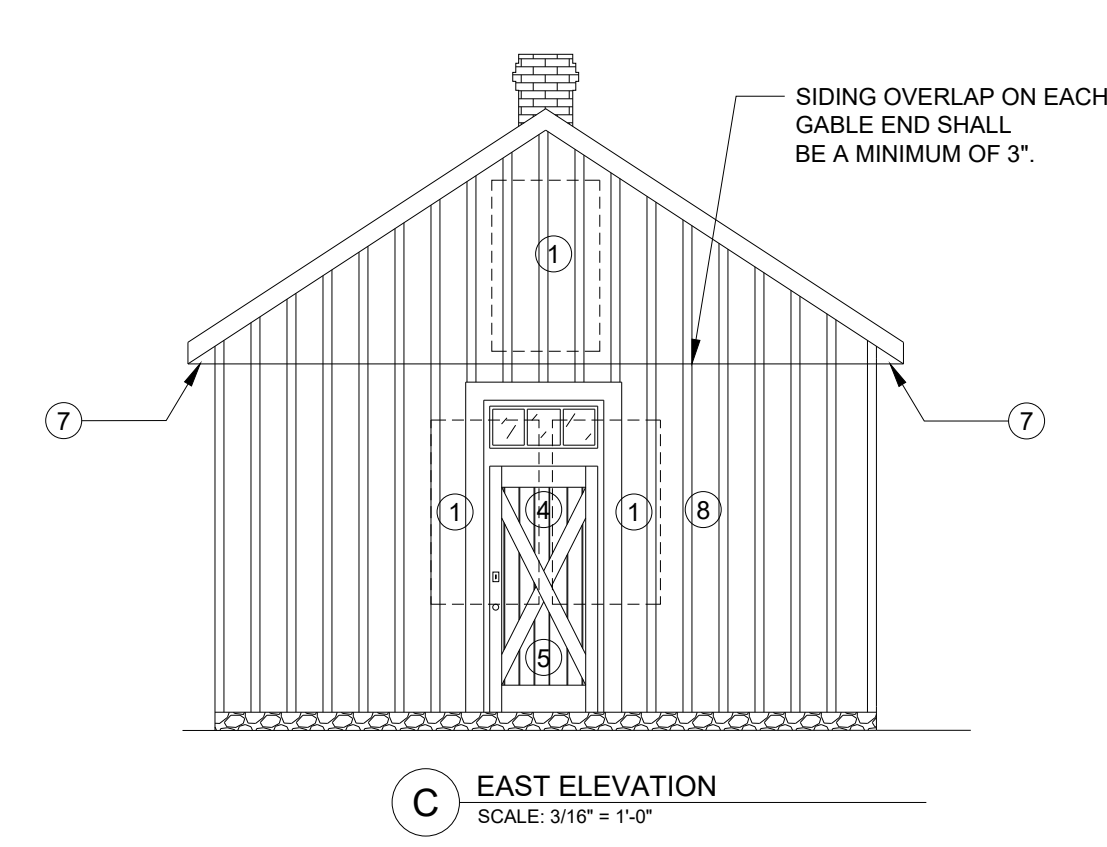
C EAST ELEVATION
SCALE: 3/16" = 1'-0"

- ① INFILL FRAMING AT DOOR AND WINDOW LOCATIONS.
- ② REINSTALL SALVAGED WINDOW UNITS.
- ③ INSTALL NEW BOARD AND BATTEN SIDING TO MATCH EXISTING.
- ④ MILL CUSTOM TRIM TO REPLICATE ORIGINAL WINDOW AND DOOR CASINGS, ETC. AS REQUIRED.
- ⑤ MILL AND FABRICATE A CUSTOM BUILT WOOD DOOR FOR THE ENTRANCE, TO INCLUDE A TRANSOM WINDOW. REFERENCE SHEETS 5 & 6 FOR DETAILS.
- ⑥ FABRICATE AND INSTALL A WOOD FRAME CRAWL SPACE ACCESS DOOR FRAME AND PANEL.
- ⑦ INSTALL NEW VENTED SOFFIT ON ALL EAVES AND SOLID SOFFIT ON ALL GABLES.
- ⑧ PAINT ALL BOARD AND BATTEN, TRIM, WINDOWS, AND DOORS PER SPECIFICATIONS.
- ! ABATE ALL ASBESTOS AND GLAZING PRIOR TO RELOCATION OF WINDOWS. REFERENCE THE ATTACHED HAZARDOUS MATERIALS REPORT FOR DETAILS.

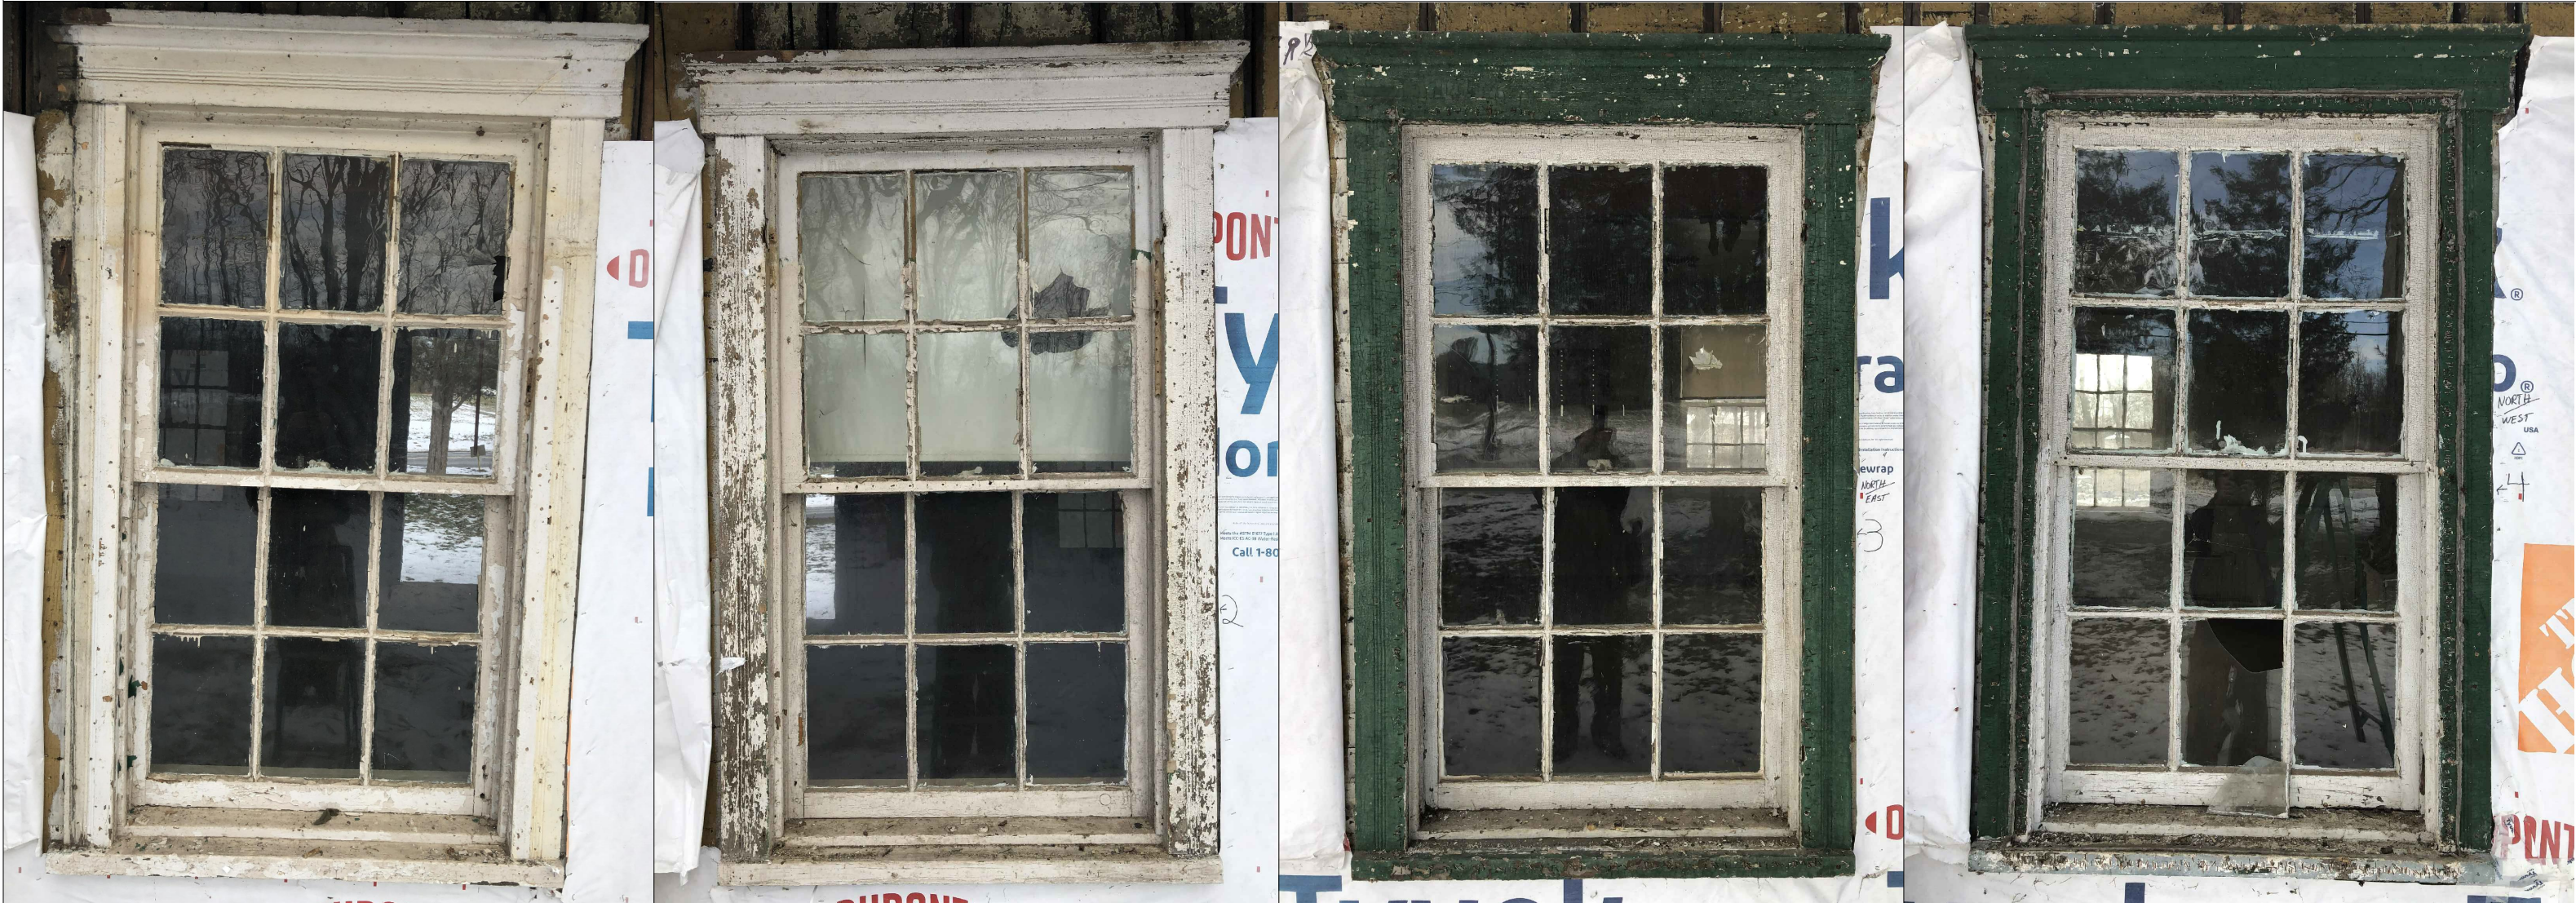
- WINDOW TO REMAIN IN CURRENT LOCATION.
- EXTERIOR TRIM TO REMAIN IN PLACE.
- PROPERLY ABATE ALL LEAD PAINT PER MDE STANDARDS.
- PROPERLY ABATE ALL ASBESTOS WINDOW GLAZING.
- AS REQUIRED, REPAIR SASH, FRAMES, AND SILL AS UNIT PRICE # 1.
- REPLACE 1 GLASS PANE AND REGLAZE / CLEAN REMAINING GLASS FROM ALL DEBRIS.
- INSTALL WEATHER STRIPPING AND REINSTALL SASH PRIME AND PAINT PER SPECIFICATION.

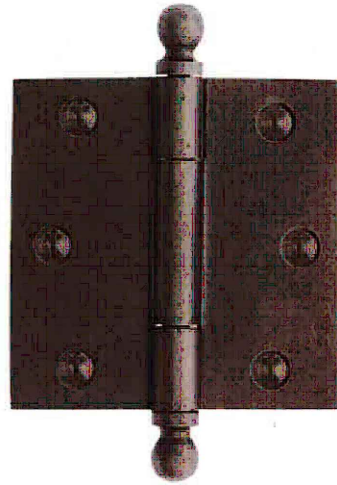
3" CAST IRON DOOR HINGE W/ BALL FINIALS. ANTIQUE PEWTER FINISH.

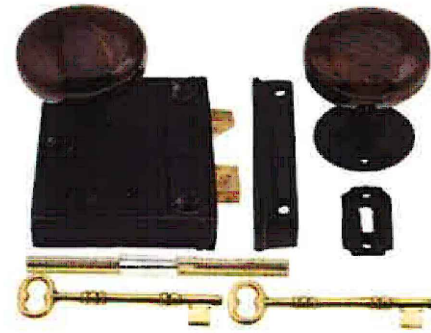
CAST IRON VERTICAL RIM LOCK SET W/ BENNINGTON STYLE KNOBS - MATTE BLACK FINISH.

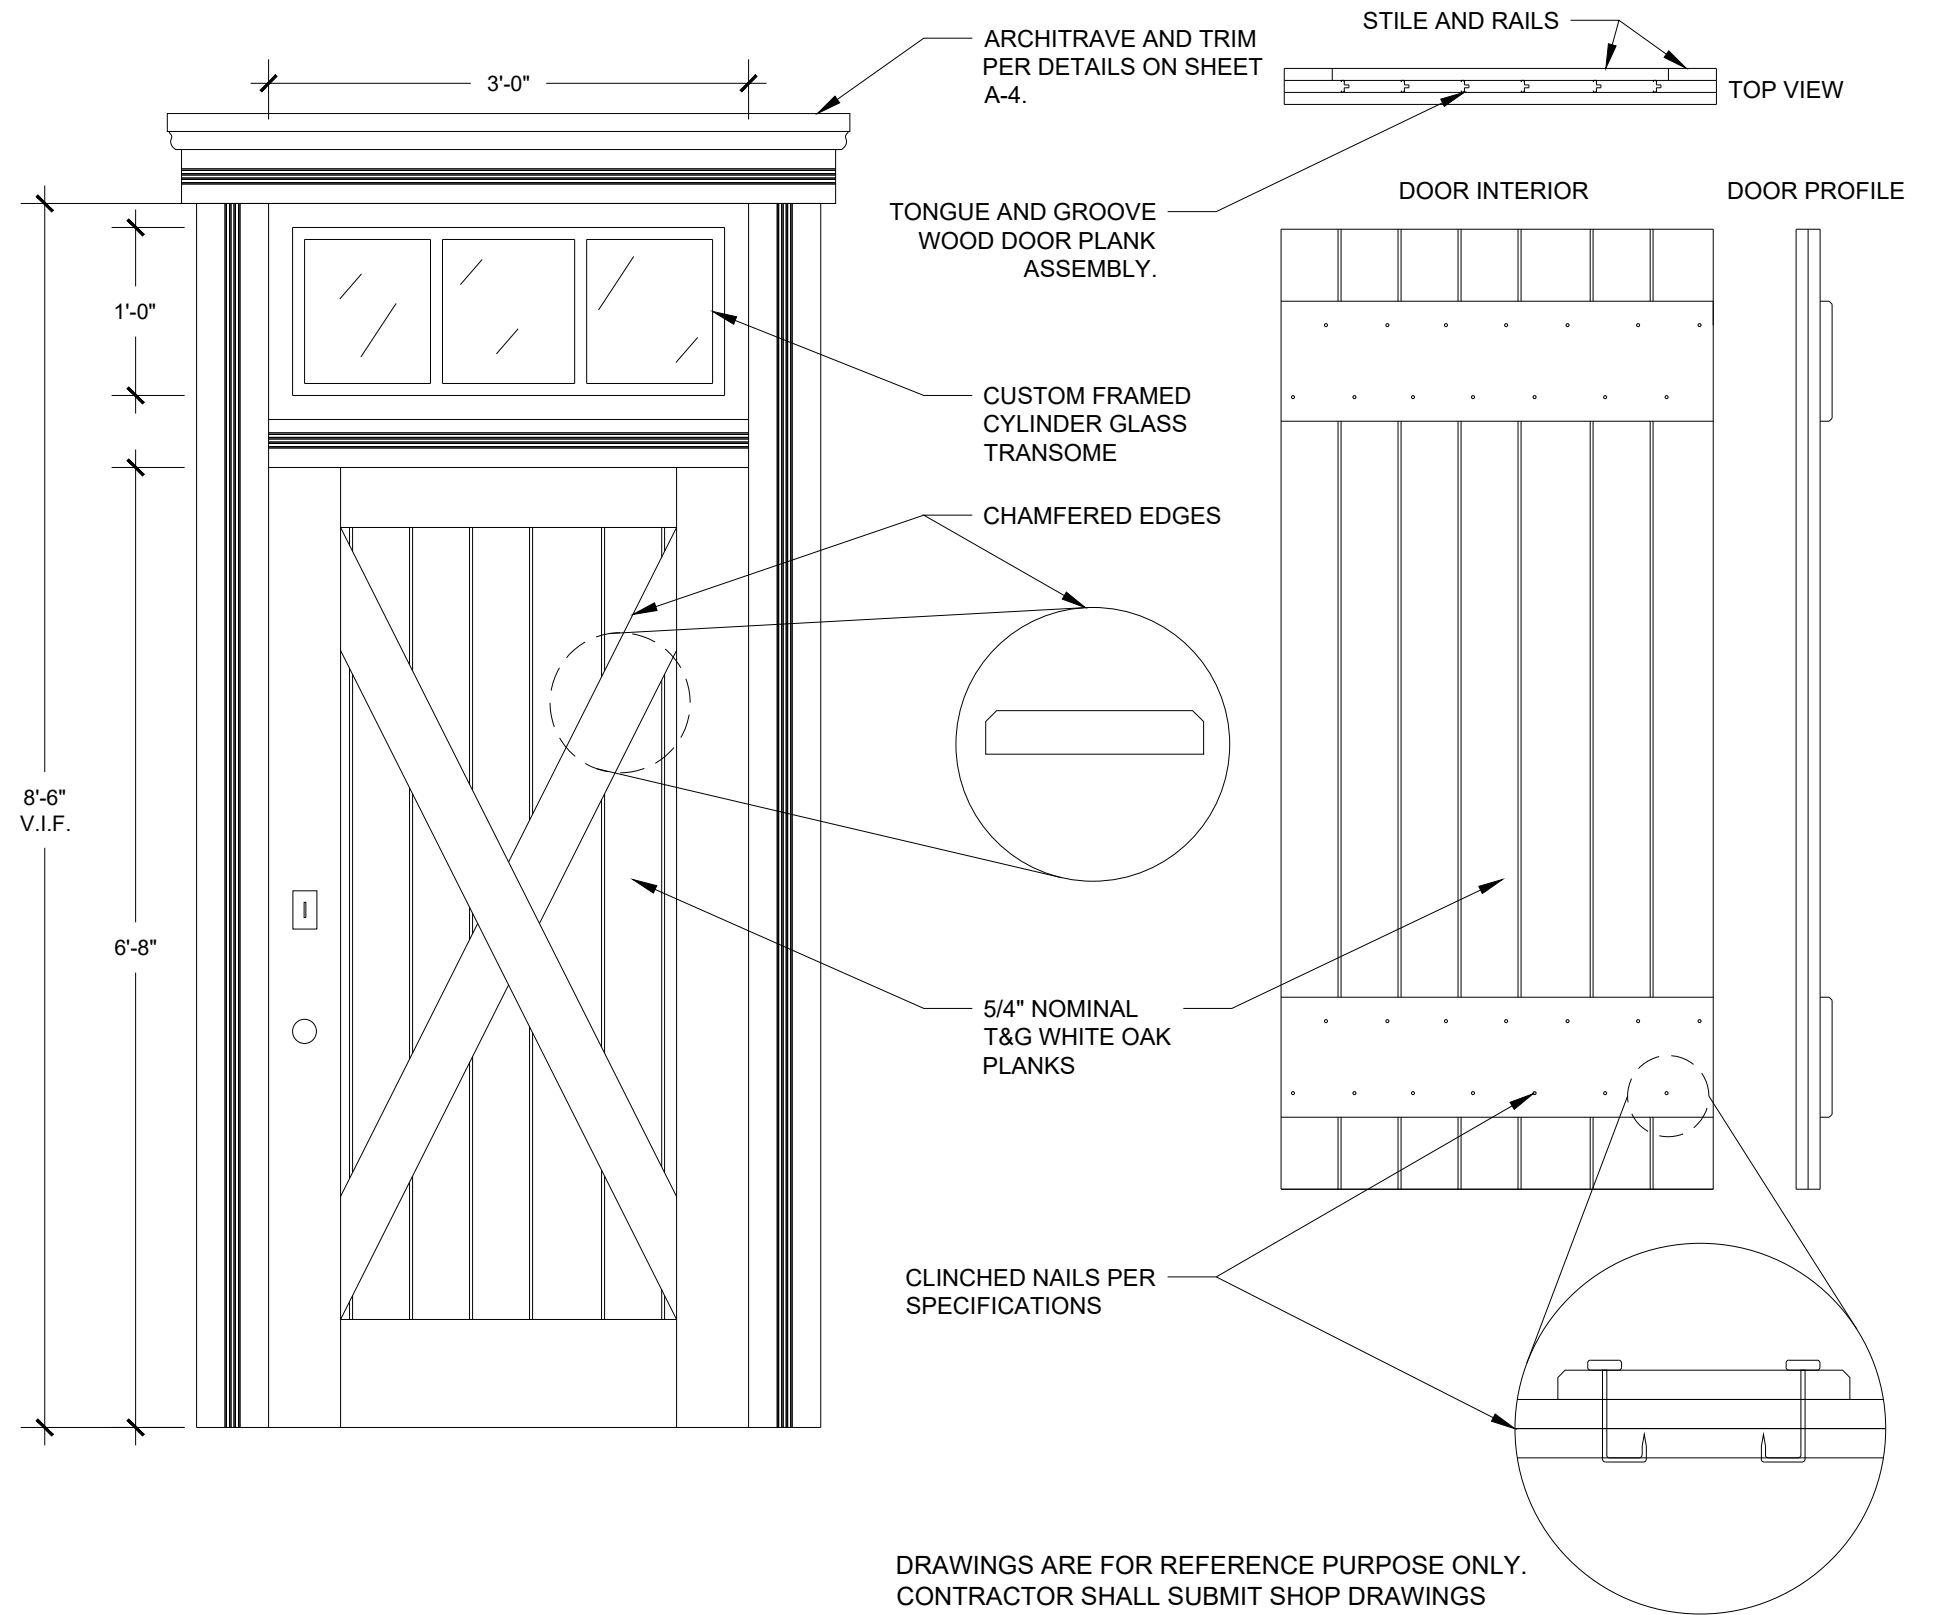
B EXTERIOR DOOR SCHEMATIC
SCALE: 3/4" = 1'-0"

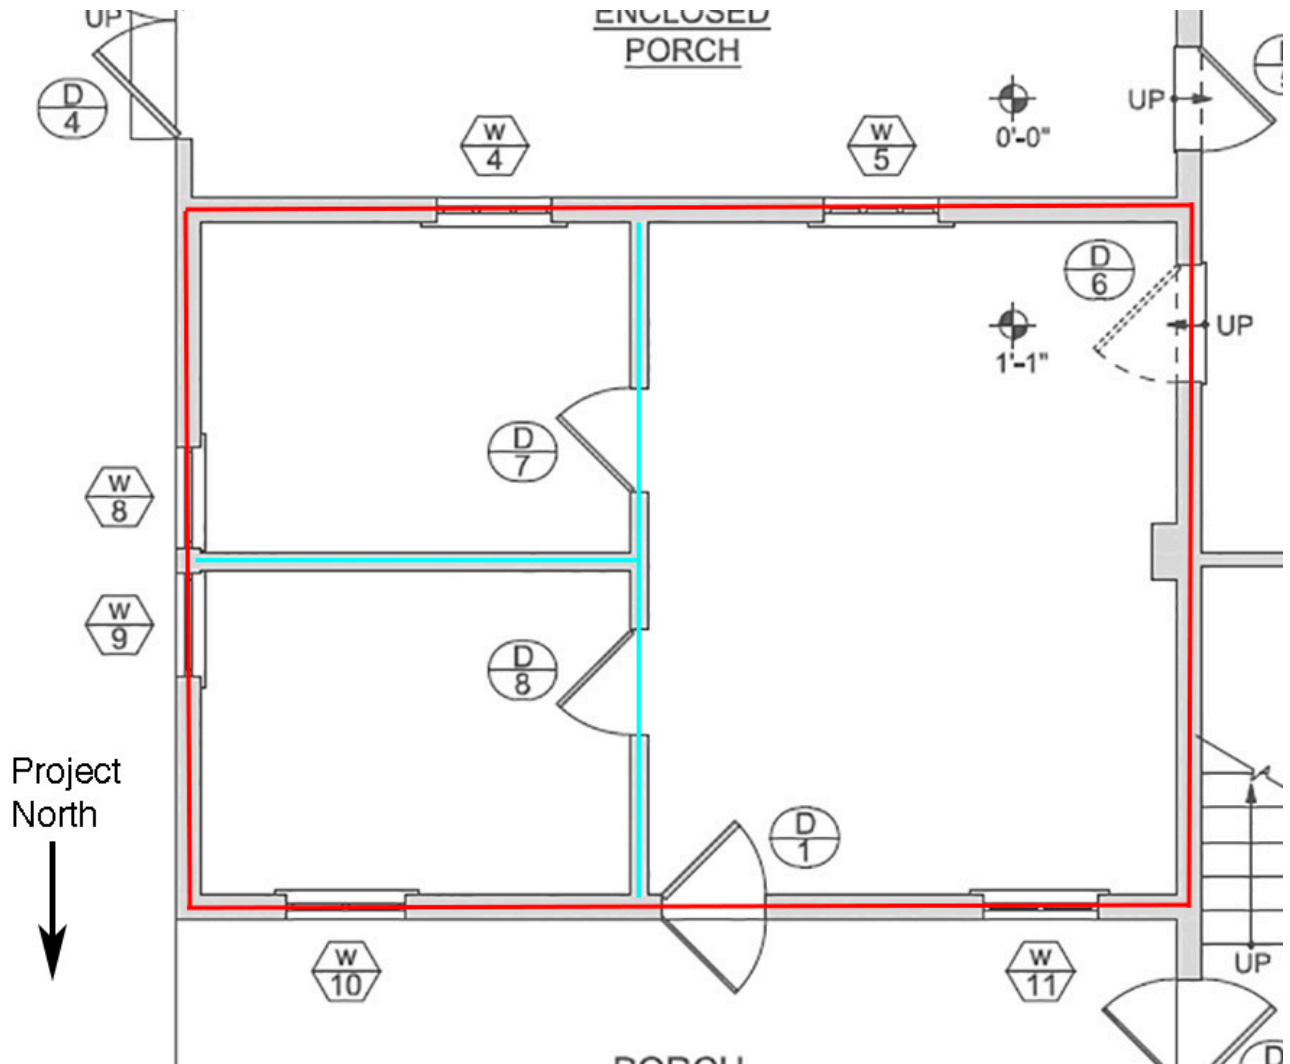
Illustration 1: The original plan of this one room schoolhouse is shown by the superimposed red lines of the drawing below.

The two windows, W8 and W9 are believed to have replaced the original door into the one room school house. In 1914 the building ceased to be a school and was sold to O. Scott Snook and it appears that there was an addition to the [project] west side and the porch added to the north. Removing the porch ceiling boards permitted a view of the original exterior board and batten siding.

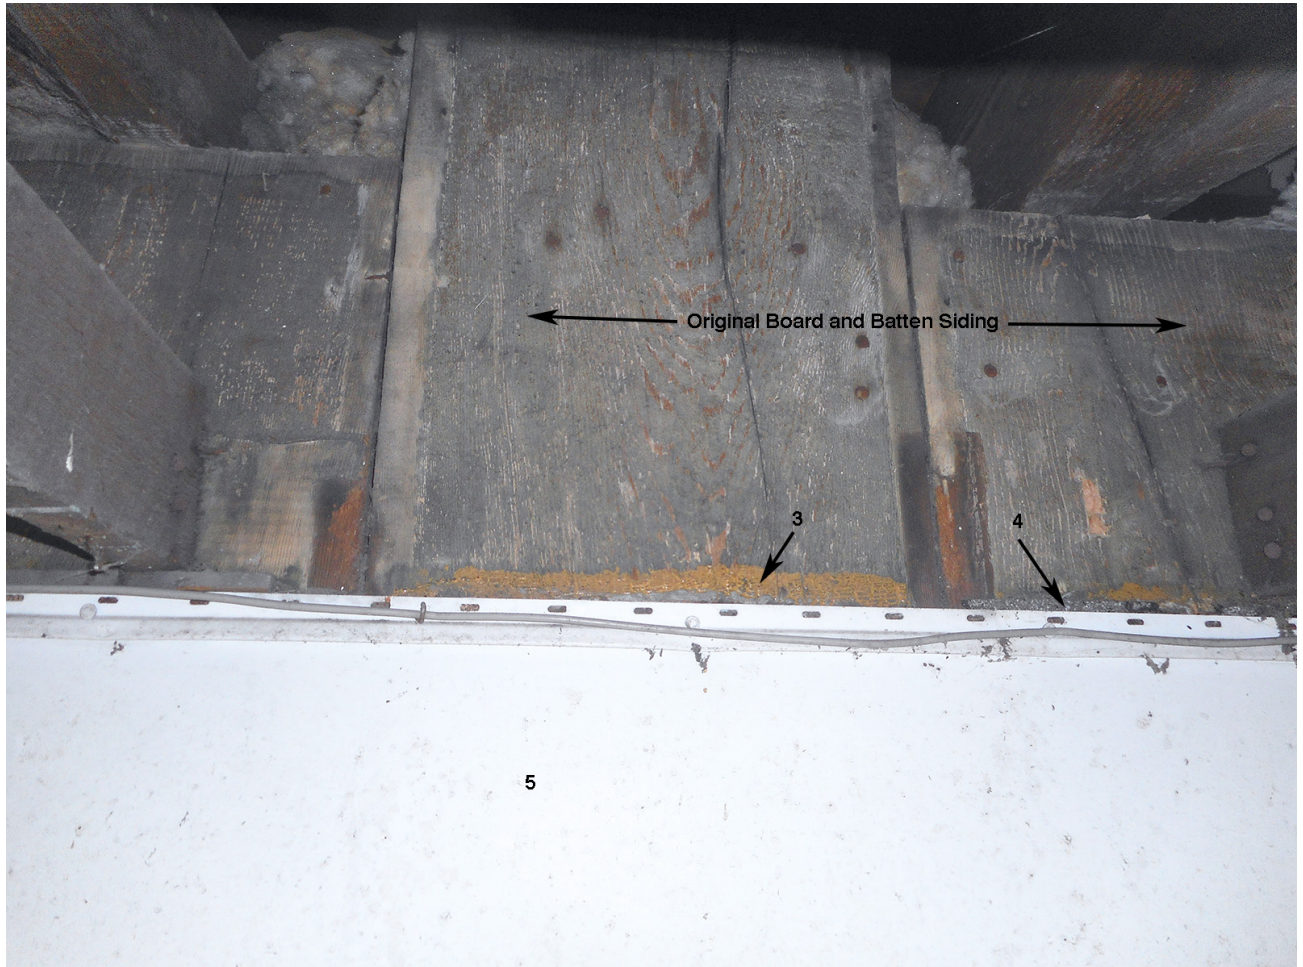
Illustration 2: North elevation, looking above the porch ceiling

Note: The ca. 1899 board and batten siding is clearly seen; [the first two finishes are on the board and batten siding]. Note the yellow enamel finish [3] that was painted at the time of the installation of the porch ceiling: this would have been 1914, when the building was sold and became a residence. The later asbestos siding [4] may be seen just above the line of the most recent aluminum siding [5]. This initial sequence indicates that there were two separate painting campaigns for the exterior when the building was the Fort Frederick Colored School.

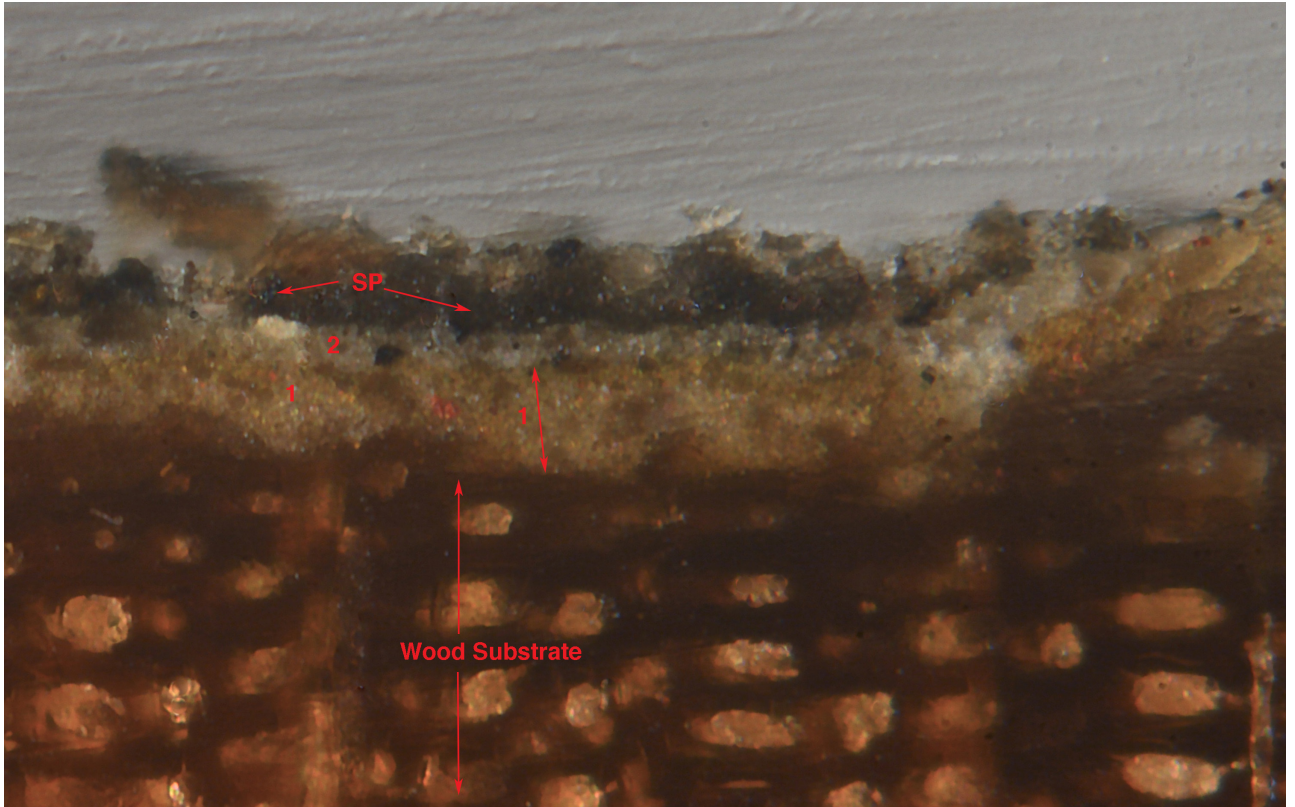
Photomicrograph: Mounted sample, Olympus BMAX-50 polarized light microscope/ 10x objective, (100x total microscopic magnification) with Nikon D7100 digital camera body Lexar Media 1GB flash card Dolan Jenner Fiber optics illuminator, daylight filtering.

Note: The sample has been mounted in polymer resin, cut and polished to 8000 micron grit polishing cloth for additional examination. The wood substrate is clearly seen at the base of the sample and is indicated. The first paint finish [1] is indicated. This finish looks dramatically different in cross section: it appears much lighter than it actually is. This appears to be due to relative particle size of the pigments used. The color is a moderate grayish brown. The first finish would date to ca. 1899. The second finish is light gray prepared with a bluish lamp black pigment in a non-lead based white base, dating to before ca. 1914. Note the exceptionally heavy surface particulate on the surface of the second finish [SP].

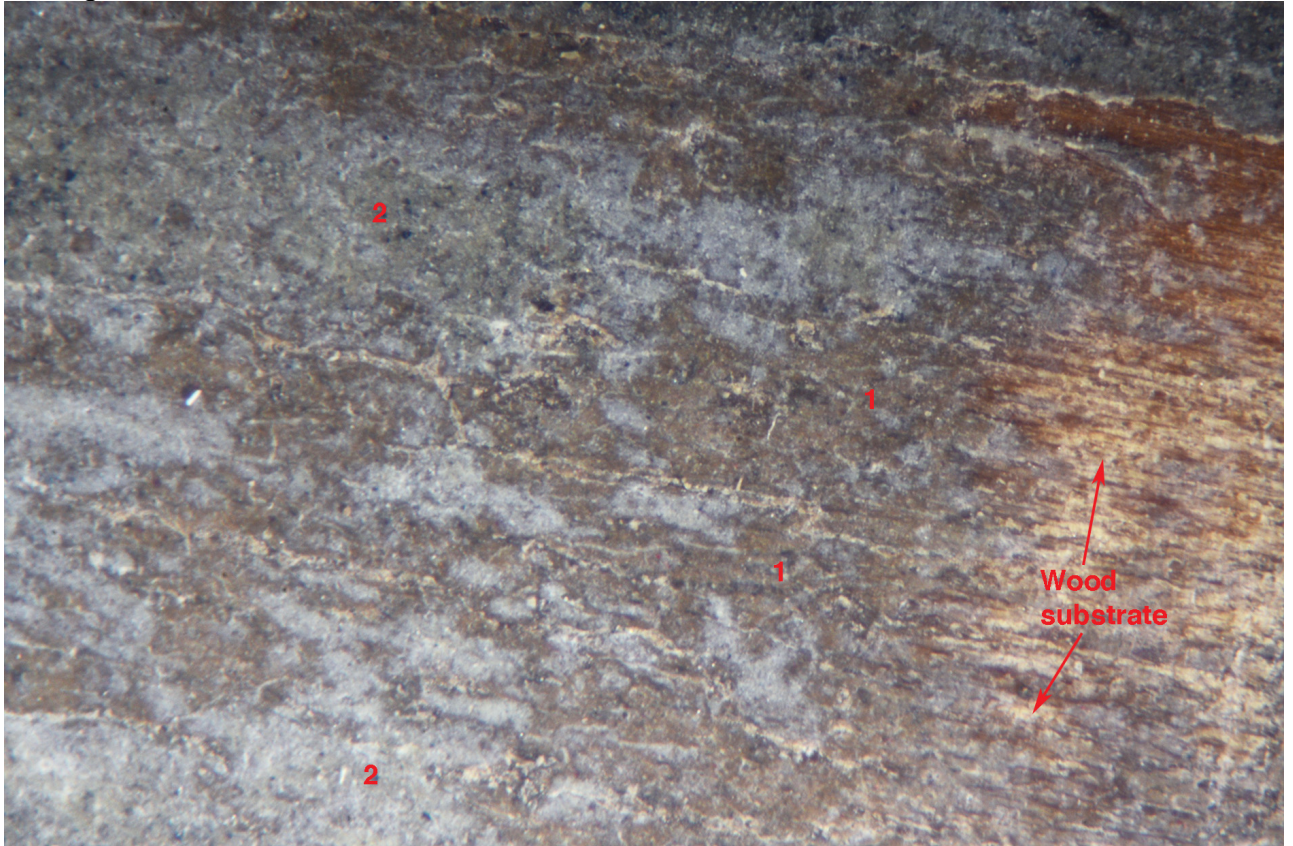
Photomicrograph: Unmounted sample, Olympus SZ-1145 microscope, with Nikon D7100 digital camera body Lexar Media 1GB flash card Dolan Jenner Fiber optics illuminator, daylight filtering

Note: The view of the sample is looking down onto the finish surface. The wood substrate has been exposed in one area and so indicated. Note that the first finish is a moderate brown [1] that presents as somewhat darker than anticipated when compared to the cross-section of the same finish. This appears to be due to the relative pigment particle size of the different pigments used. The second finish is a moderate gray, prepared with a cool lamp black, creating a bluish gray: the last finish on the surface, it would have been exposed at the time of the sale of the schoolhouse in 1914.

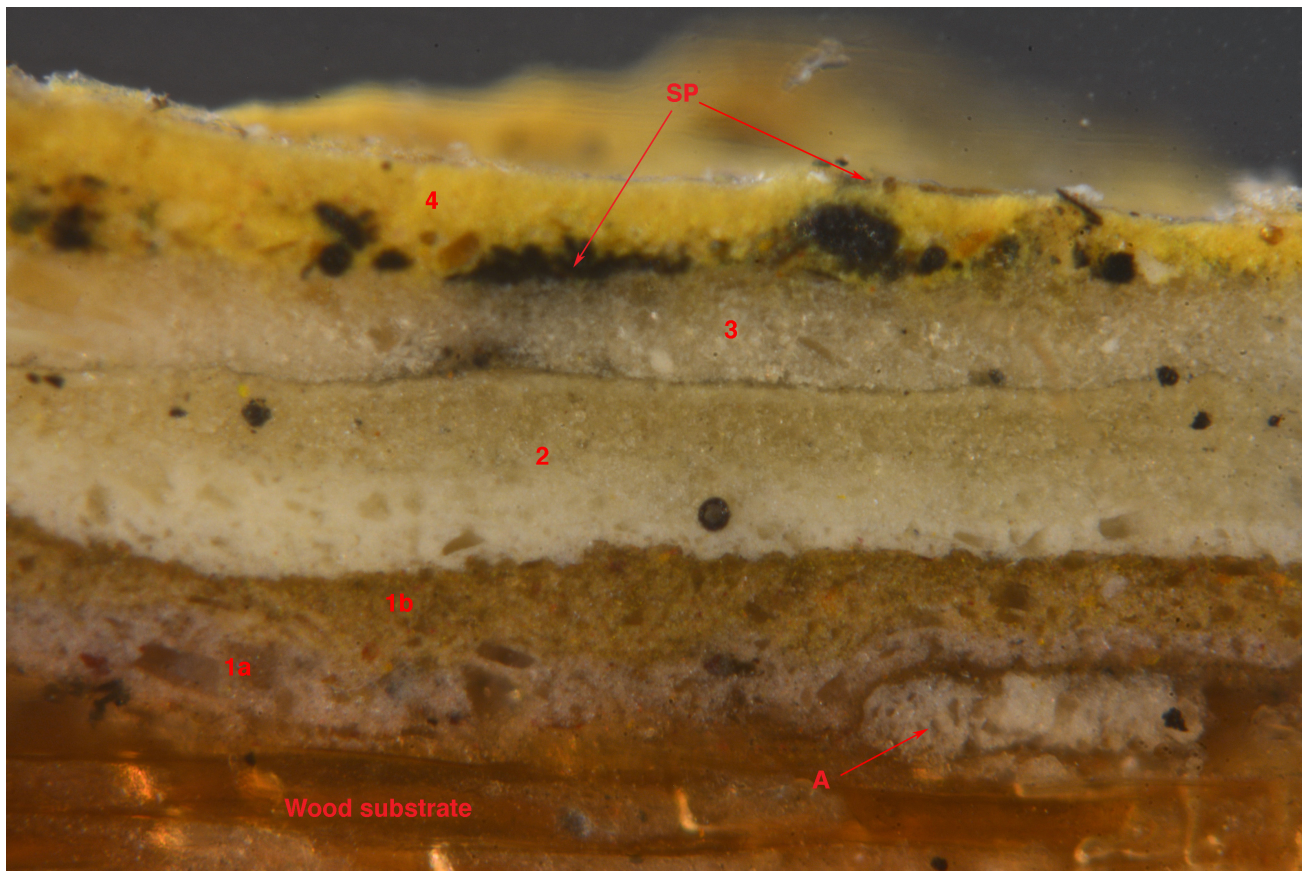
Photomicrograph: Mounted sample, Olympus BMAX-50 polarized light microscope/ 10x objective, (100x total microscopic magnification) with Nikon D7100 digital camera body Lexar Media 1GB flash card Dolan Jenner Fiber optics illuminator, daylight filtering.

Note: The sample has been mounted in polymer resin, cut and polished to 8000 micron grit polishing cloth for additional examination. The wood substrate is clearly seen at the base of the sample and is indicated. Note that there are remnants of an earlier white finish [A] suggesting that the board may have been reused. The first paint finish [1] is indicated: this sample appears to be much closer to the actual paint color. The color is a moderate grayish brown. The first finish would date to ca. 1899. The second finish is light gray prepared with a bluish lamp black pigment in a non-lead based white base, dating to before ca. 1914. Here, the first layer appears to be white, with a discolored, light gray as the finish. There is an additional light gray layer, which may be a “touch up” maintenance coating. The last finish, [4 in this sequence] is the yellow enamel seen in Illustration 2: North elevation, looking above the porch ceiling.

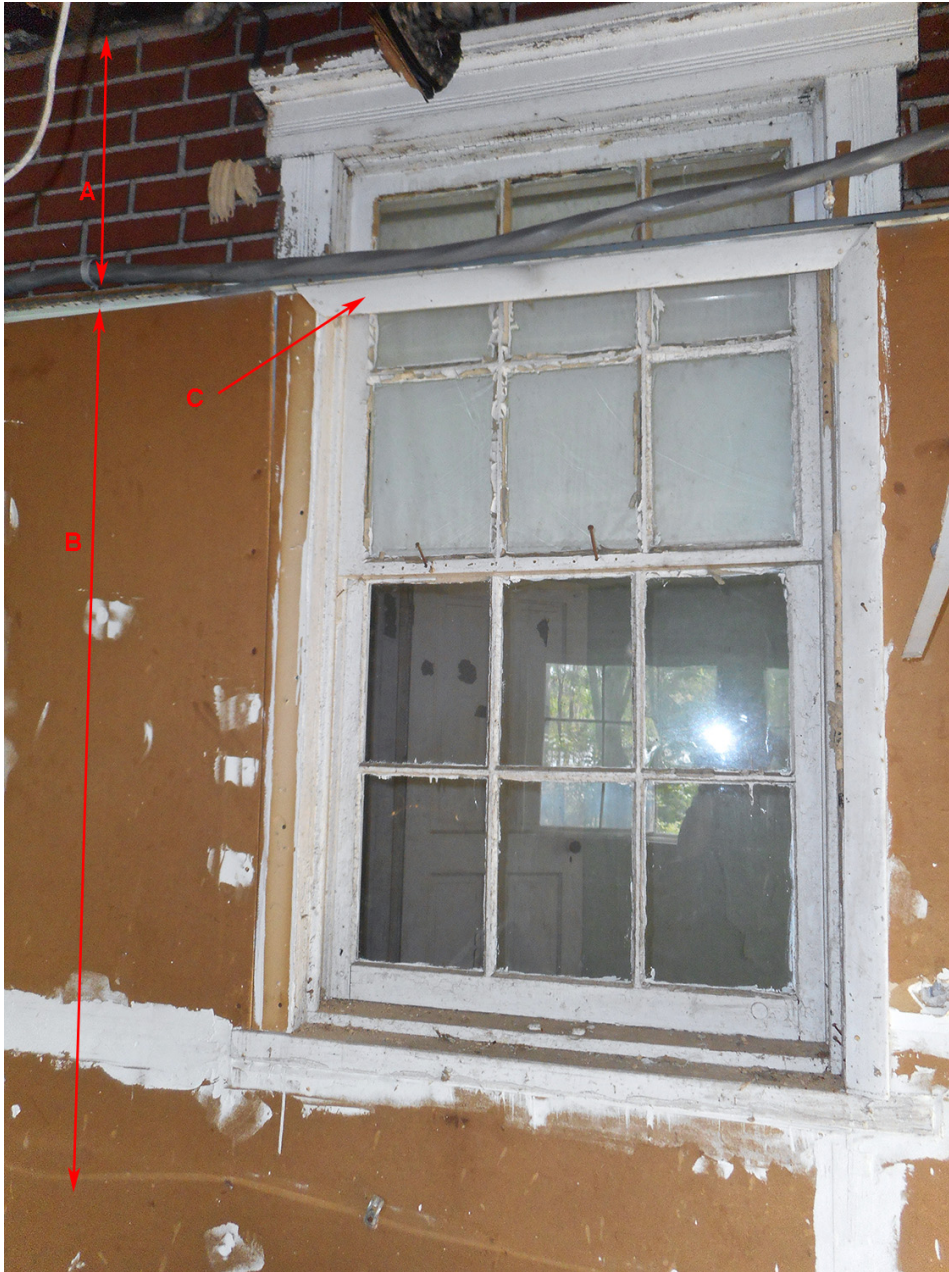
Site photograph: South Elevation post 1914 asbestos siding and later changes.

Note: The entire surface of the board and batten siding of the south elevation was covered with the asbestos siding, in a brick pattern [A]. Later, the ceiling of the south porch was dropped [B] that also reduced the height of the window, including a new frame [C].

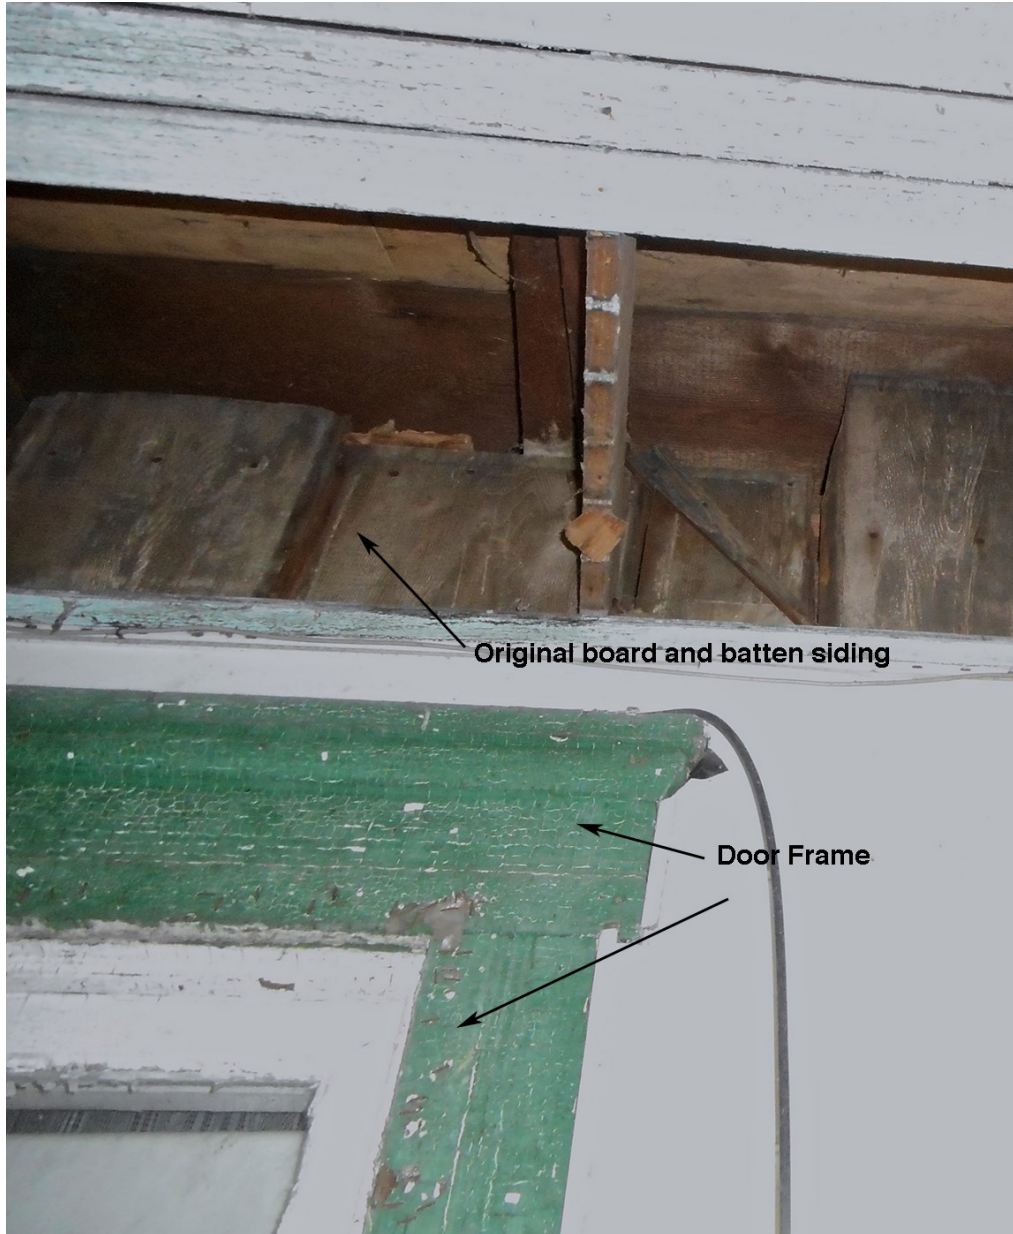
North Elevation: Door frame

Note: The door frame of the North Door may have been re-used from the East elevation and thus would have been the original door frame. The door itself is clearly from the post-school period, and the door frame may have been re-configured when moved to the north elevation. The paint layering **is not conclusive**. The first finish, the light gray would have been a standard color at the time.

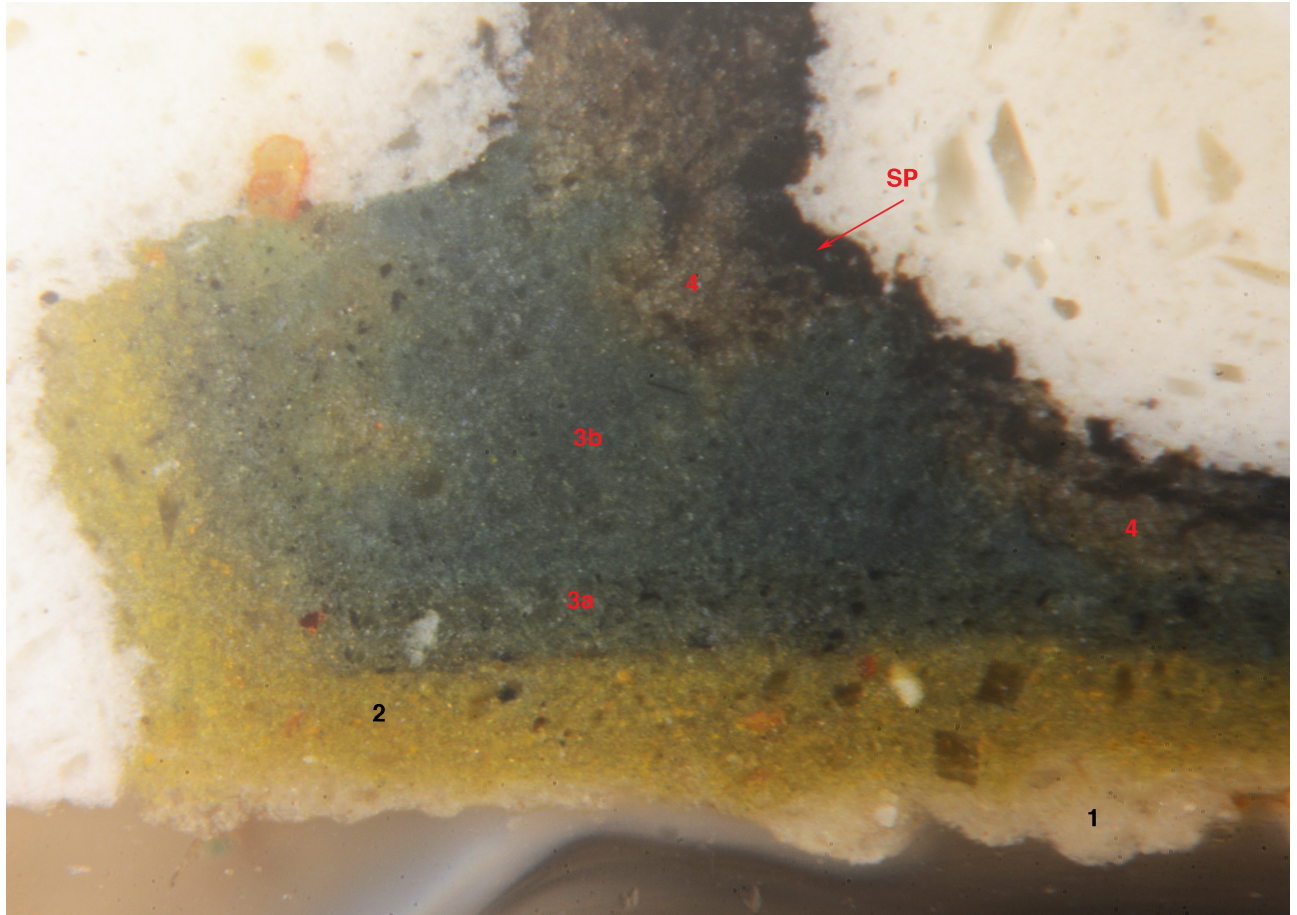
Photomicrograph: Mounted sample, Olympus BMAX-50 polarized light microscope/ 10x objective, (100x total microscopic magnification) with Nikon D7100 digital camera body Lexar Media 1GB flash card Dolan Jenner Fiber optics illuminator, daylight filtering.

Note: The sample has been mounted in polymer resin, cut and polished to 8000 micron grit polishing cloth for additional examination. **Note: most if these paint layers are discolored, and do not present correctly in cross section.** The first layer [1] is a worn layer of the first finish, and is discolored; the color was actually a light gray. The second layer [2] is the second finish, a moderate yellowish green [appears much lighter and yellowish]. The third finish [3] would date to the sale of the school house and thus post dates the original use. The dark gray, [4] appears to be the same dark gray that is seen on the interior.

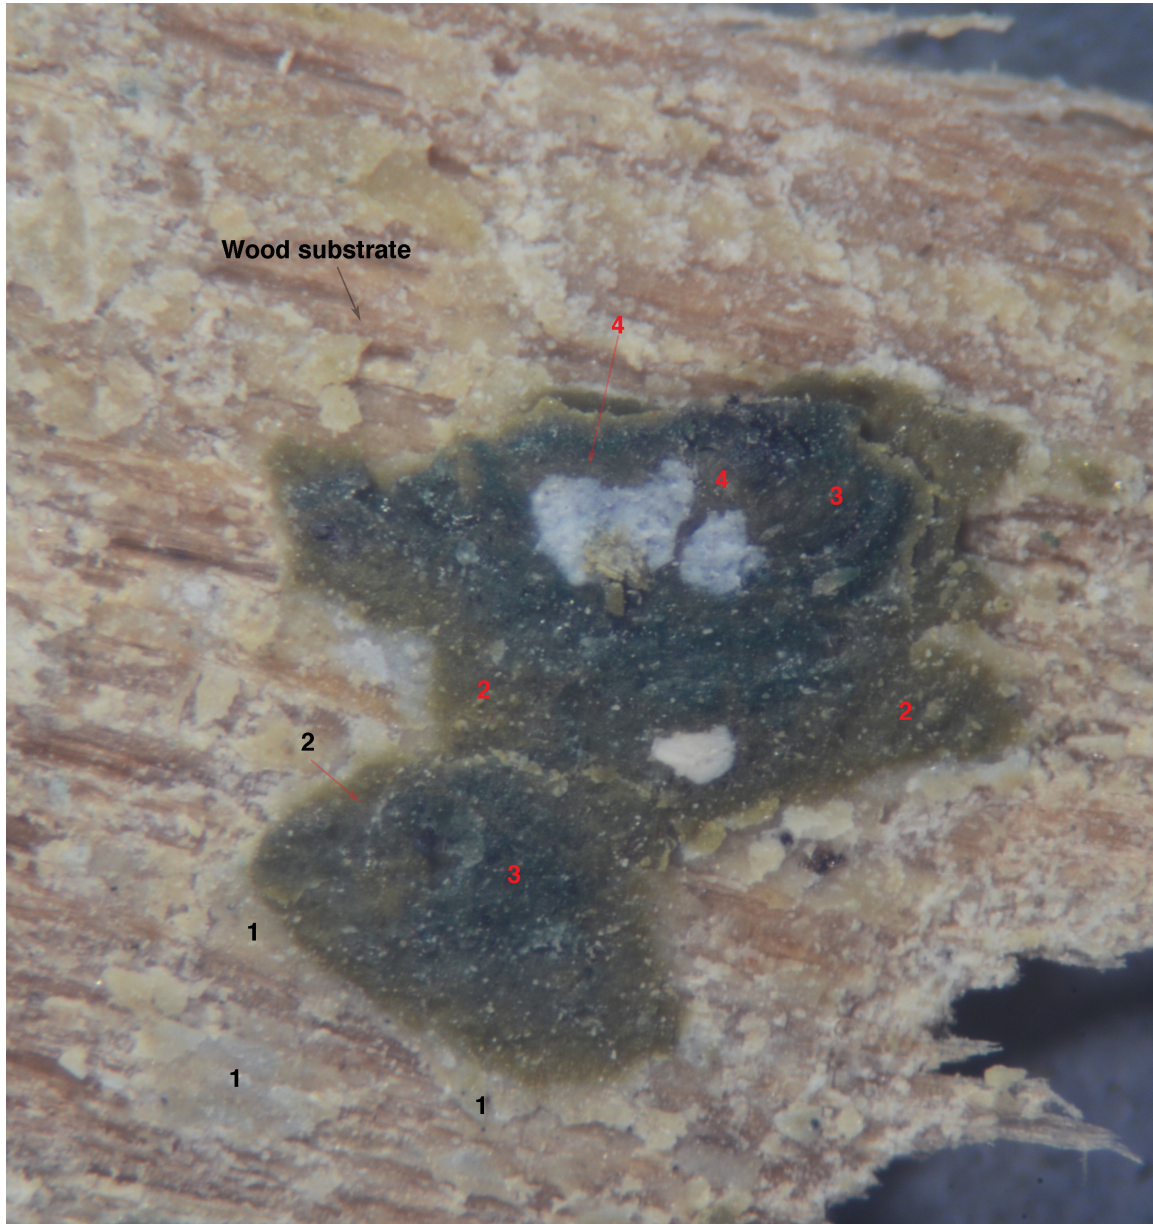
Photomicrograph: Unmounted sample, Olympus SZ-1145 microscope, with Nikon D7100 digital camera body Lexar Media 1GB flash card Dolan Jenner Fiber optics illuminator, daylight filtering

Note: The view of the sample is looking down onto the finish surface. The wood substrate is clearly seen. The first finish is very discolored, with only a few locations retaining the light gray original color [1]. The second finish is the moderate yellowish green “moss green” that is better rendered in this unmounted sample. Finishes 1 and 2 cover the period when the building was a school house. The third finish dates to the ca. 1914 changes. The dark gray [4] also appears to relate to the dark gray on the interior.
