PRESERVATION MARYLAND

INVITATION TO BID

Williams Schoolhouse Phase II Restoration

Attachment B

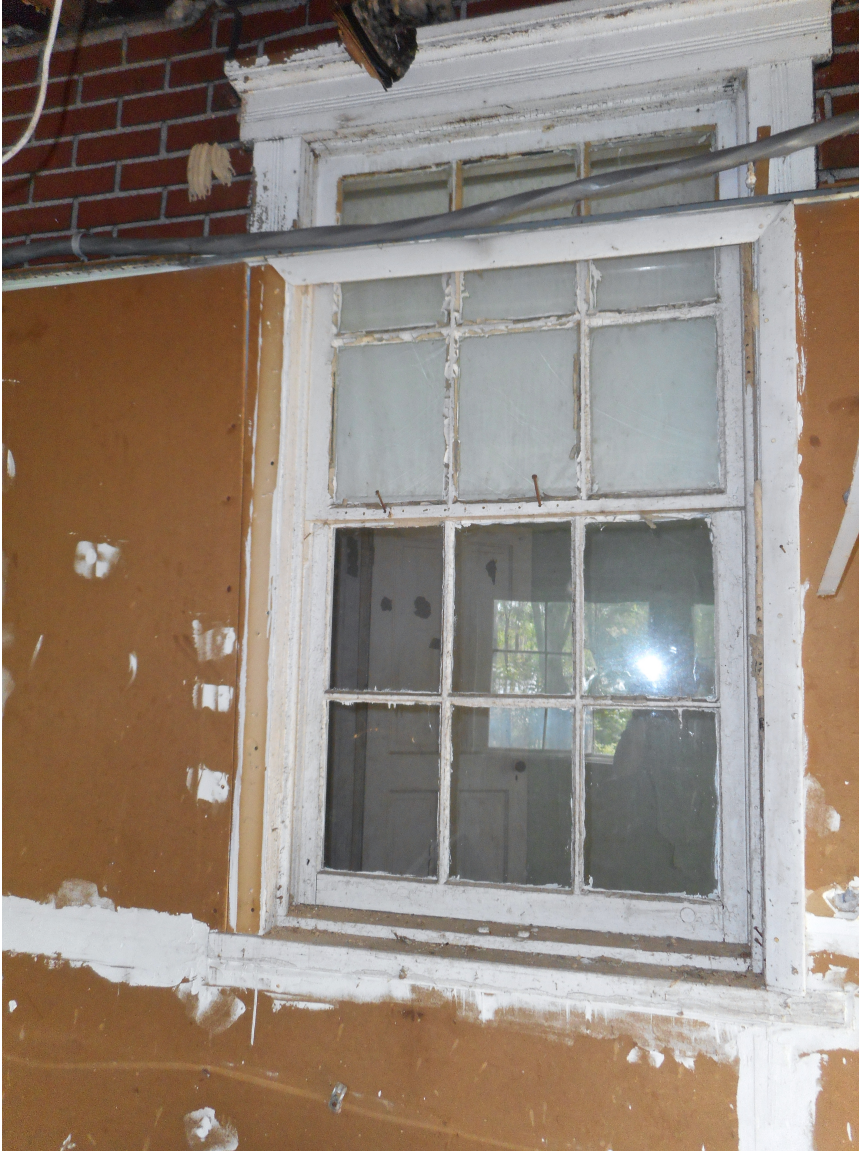
Window Frames:

Note: The window W 4, seen above has been protected for decades by the south porch. Note also the burying of the window frame under later wall board and framing.

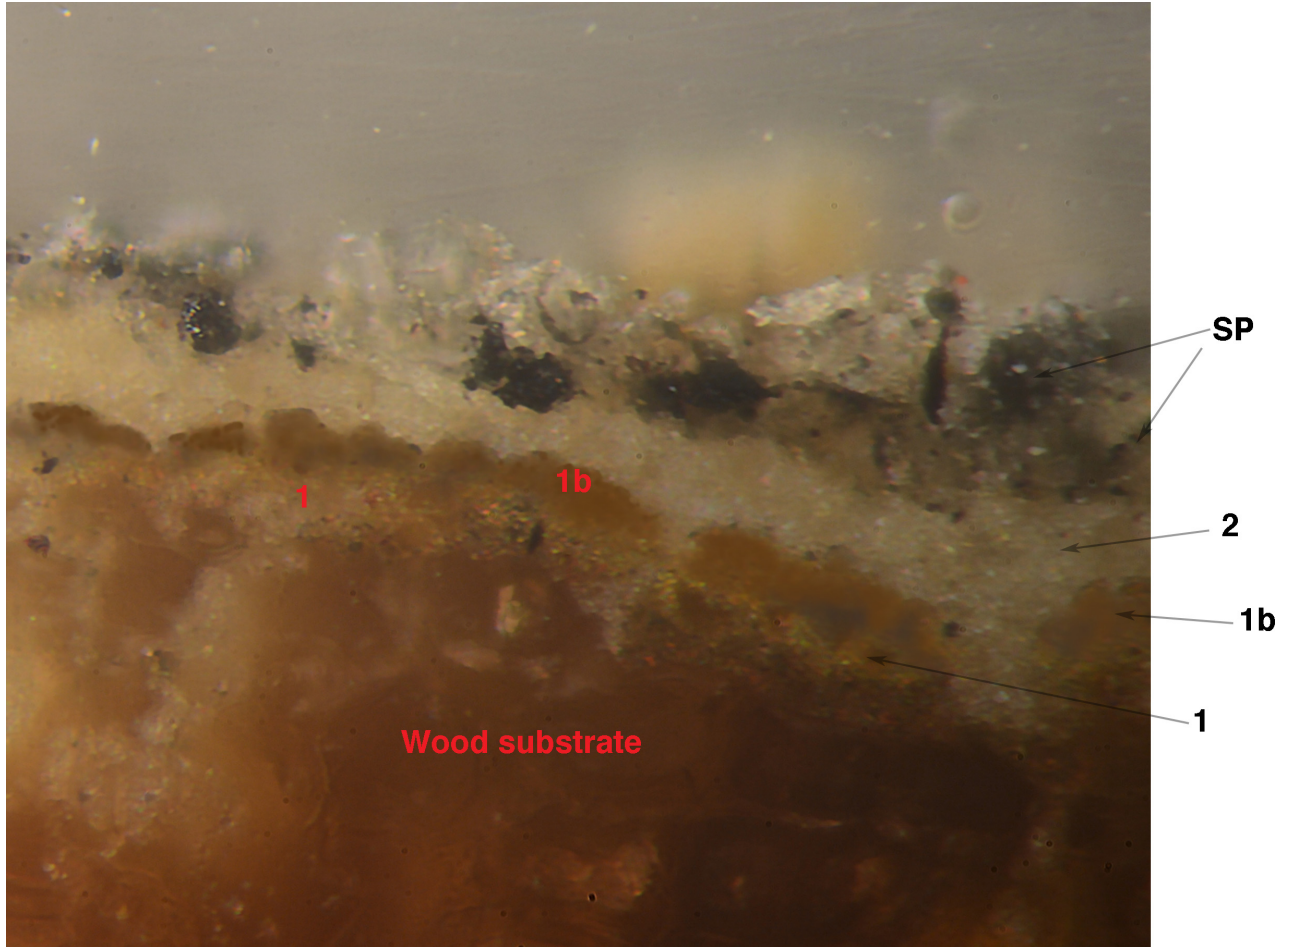
Photomicrograph: Mounted sample, Olympus BMAX-50 polarized light microscope/ 20x objective, (200x total microscopic magnification) with Nikon D7100 digital camera body Lexar Media 1GB flash card Dolan Jenner Fiber optics illuminator, daylight filtering.

Note: The sample has been mounted in polymer resin, cut and polished to 8000 micron grit polishing cloth for additional examination. The wood substrate is seen at the base of the sample and is indicated. The brown finish [1] is clearly seen: this paint shows much lighter in cross section than it actually is. The lighter appearance may be due to the lower quality of the paint material. Indeed, there is a later application of varnish [1b] which was applied in order to extend the usable life of the paint. The second finish is the light gray [2].

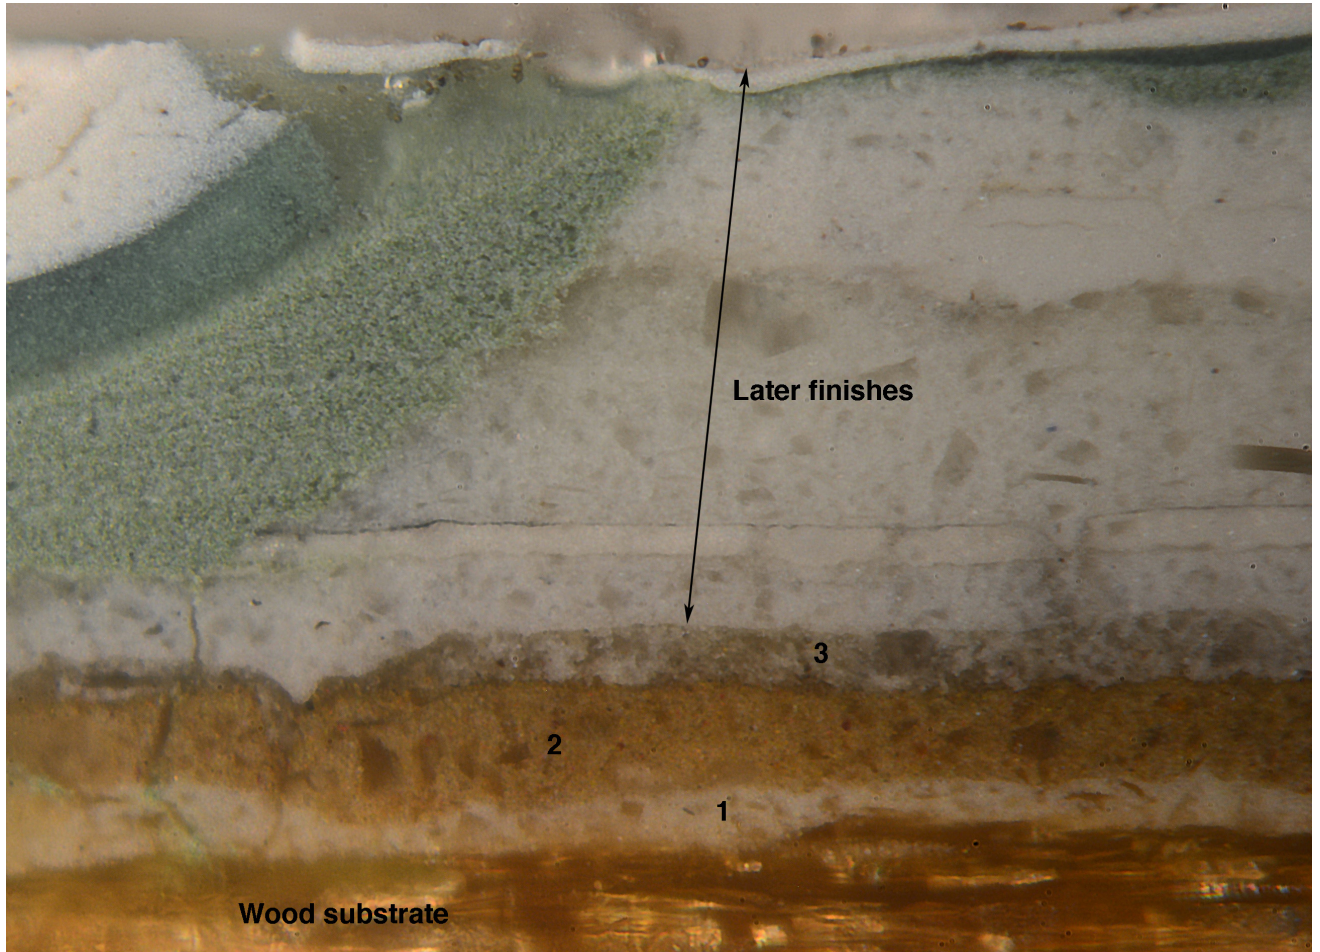
Photomicrograph: Mounted sample, Olympus BMAX-50 polarized light microscope/ 10x objective, (100x total microscopic magnification) with Nikon D7100 digital camera body Lexar Media 1GB flash card Dolan Jenner Fiber optics illuminator, daylight filtering.

Note: The sample has been mounted in polymer resin, cut and polished to 8000 micron grit polishing cloth for additional examination. The wood substrate is seen at the base of the sample and is indicated. The first finish is a grayish white finish [1] which contrasts with the brown of the window frame. The second finish [2] is a moderate brown, which also appears lighter in the cross section. The third finish is a moderate gray, which would date to ca. 1914. A series of later finishes are also visible.

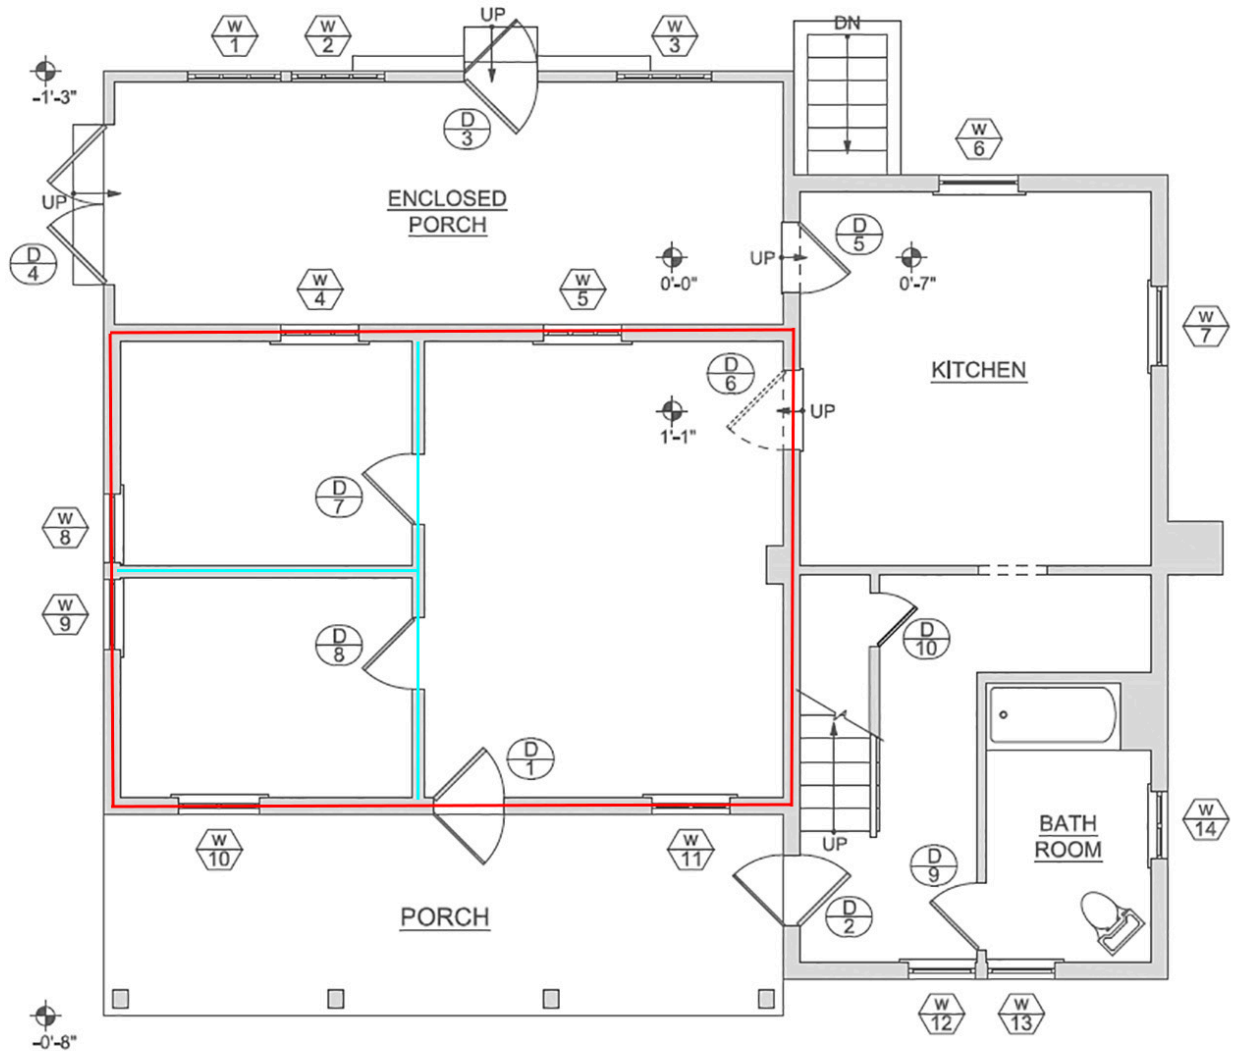
The original school building has been enlarged at the time that it was converted into a house, ca. 1914. The original schoolroom is seen below, outlined in red.

The subdivision of the room was accomplished with the introduction of the walls shown in light blue. The project west wall retained much original building fabric. Both woodwork and plaster appears to survive relatively intact.

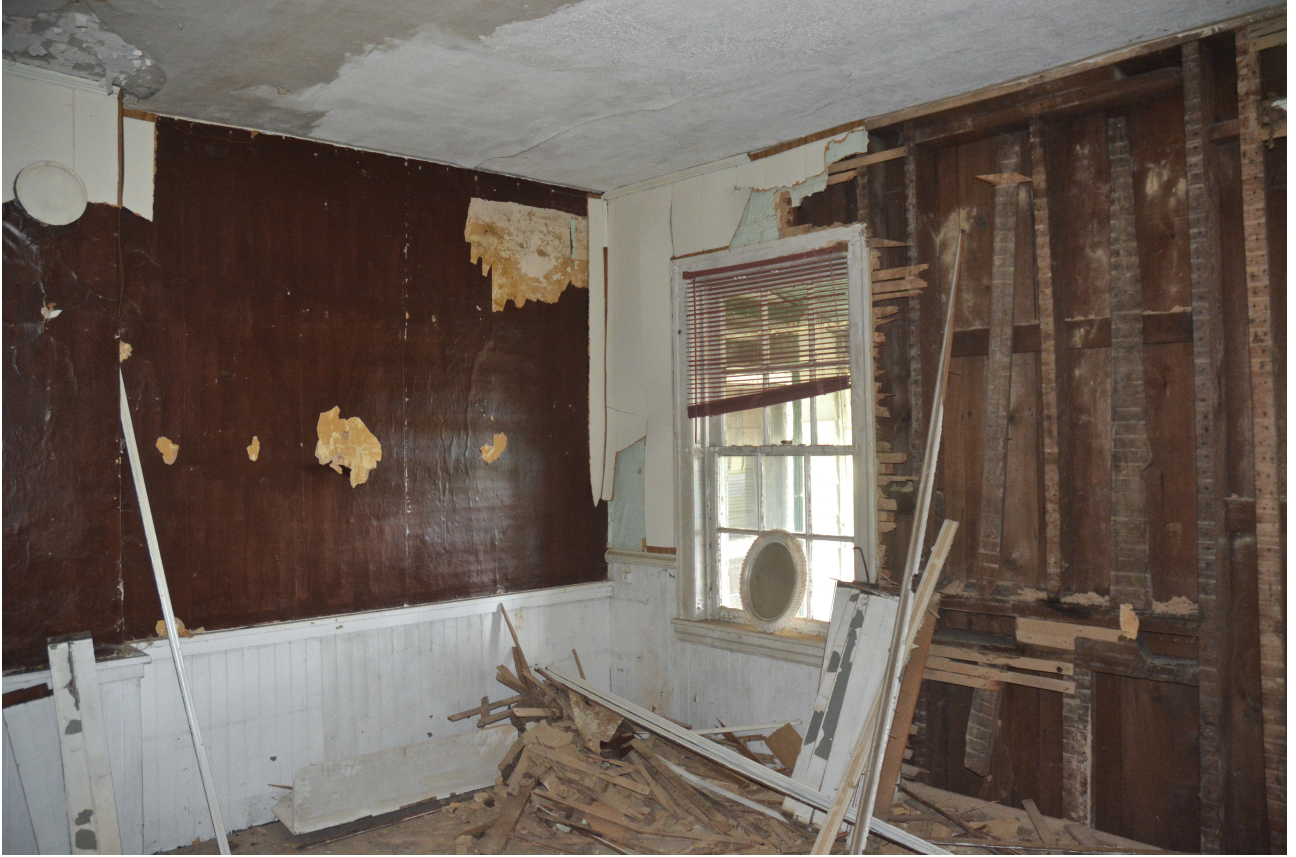
Interior: View of the west wall of the School house

Note: The west wall is on the left in this view. The windows of the adjacent north wall have been moved at the time of the conversion of the school into a house. The wainscot of the west wall is original.

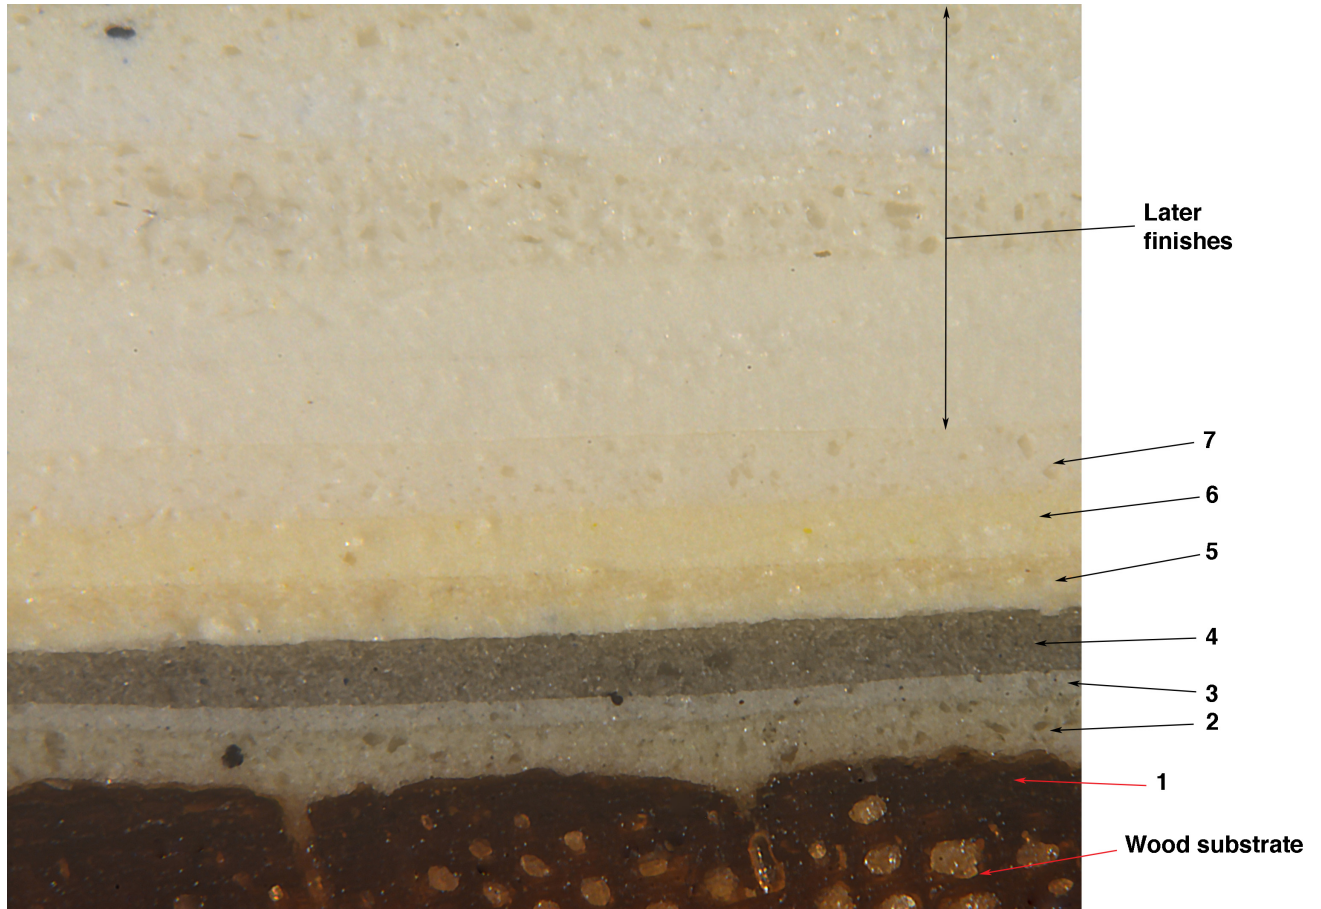
Note: The sample has been mounted in polymer resin, cut and polished to 8000 micron grit polishing cloth for additional examination. The wood substrate is seen at the base of the sample. The first finish, the original finish [1] is a dark shellac: this appears to be a red shellac, probably a common garnet shellac. Note that it was exposed for a considerable period of time before being overcoated: the shellac had cracked [“alligatored”] and no doubt the second finish [2, a light greenish gray] is post 1914, when the building was no longer used as a school. This is confirmed by comparison with the added door frame to the added kitchen, seen below.

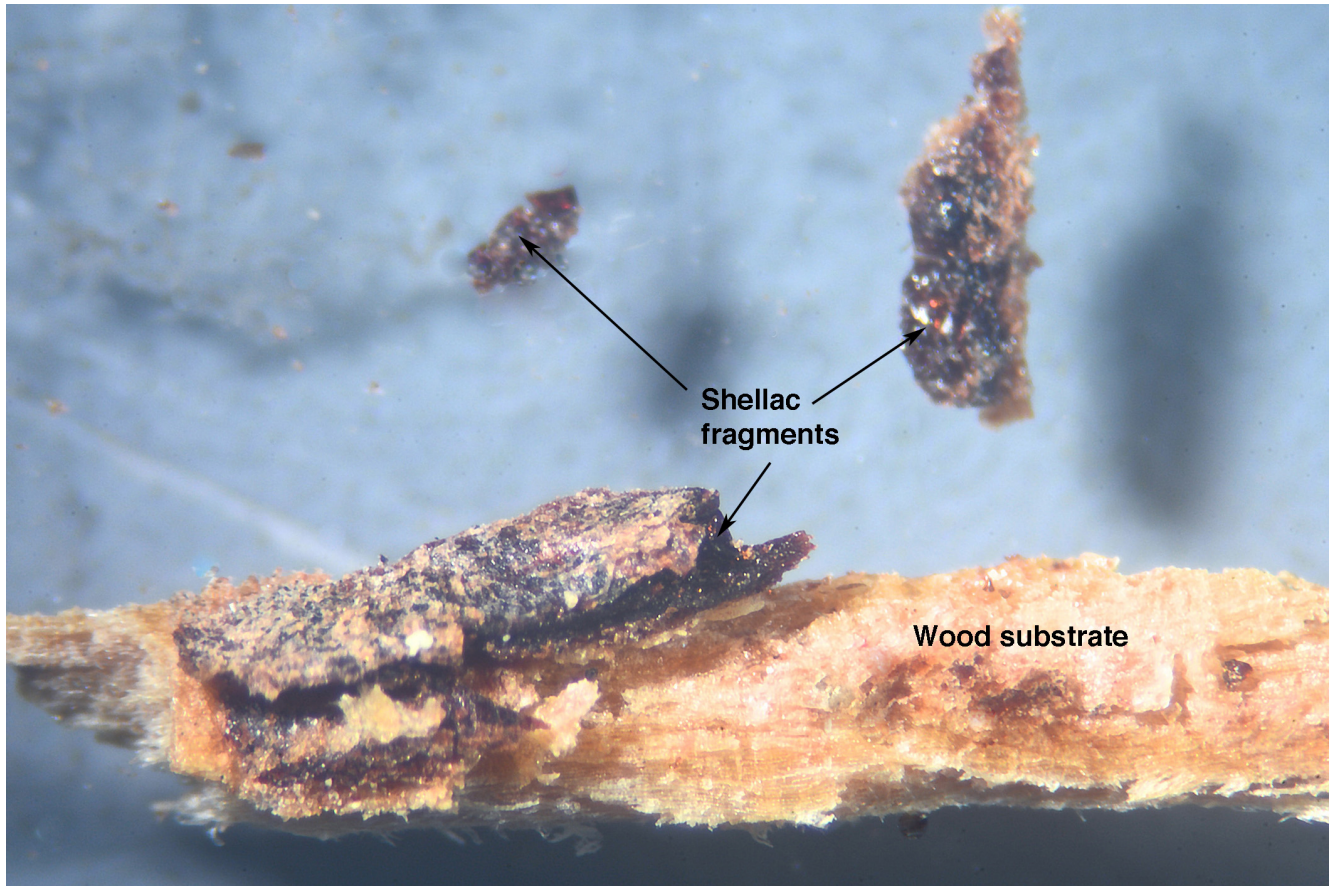
Note: The view of the sample is looking toward the side, capturing the wood substrate as well as the surviving coating. The fragment of wood substrate is clearly seen. Note the accumulated layers of shellac, somewhat thicker than seen on the general surface, since this was a hairline crack in the wood that filled with the shellac coating when it was applied. This is the only surviving evidence of the original shellac finish on the cap of the chair rail, since it appears that all of the surfaces were scraped and sanded smooth, removing the original shellac finish. Refer to Note below.

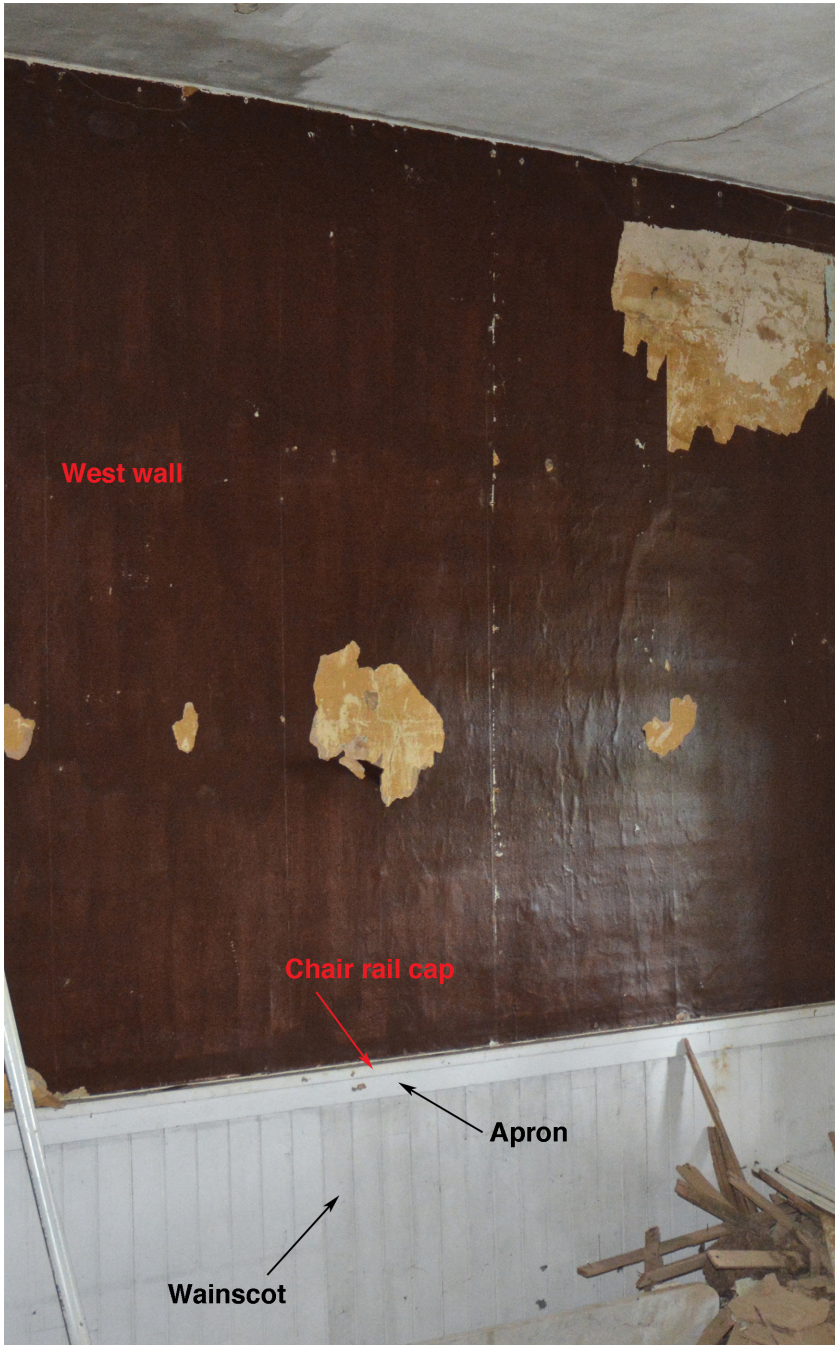
Note regarding the original finish of the chair rail cap

The sample of the chair rail cap included a thin crack in the wood that had been there since construction. The crack filled with the dark reddish shellac. The wainscot vertical boards and the apron clearly show the survival of the original shellac finish. The chair rail cap, however, appears to have been sanded smooth of all of the shellac finish, excepting only that which filled the crack in the wood. This is unusual in the extreme, however, all of the other finishes date to the post-addition period. While extremely odd, the surviving physical evidence supports that the chair rail cap would also have been finished with the same garnet red shellac.

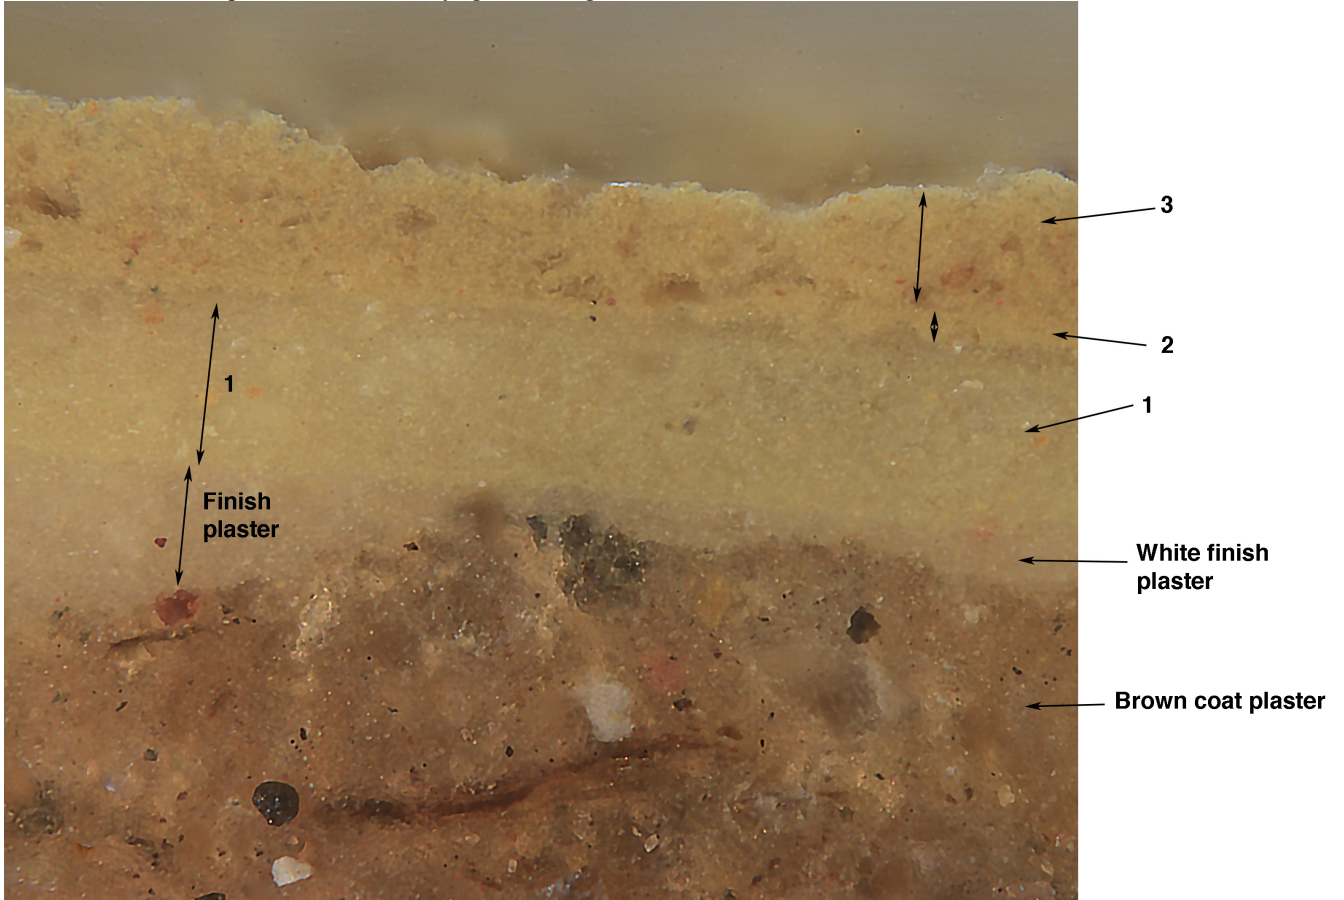
Note: The sample has been mounted in polymer resin, cut and polished to 8000 micron grit polishing cloth for additional examination. The brown [scratch] coat is clearly seen, and there is a very thin white finish plaster layer, also noted. The first paint coating is a light yellow ochre finish, built up of two layers that have effectively merged together [1]. This is the period of historical interest. These colors appear lighter in cross section.

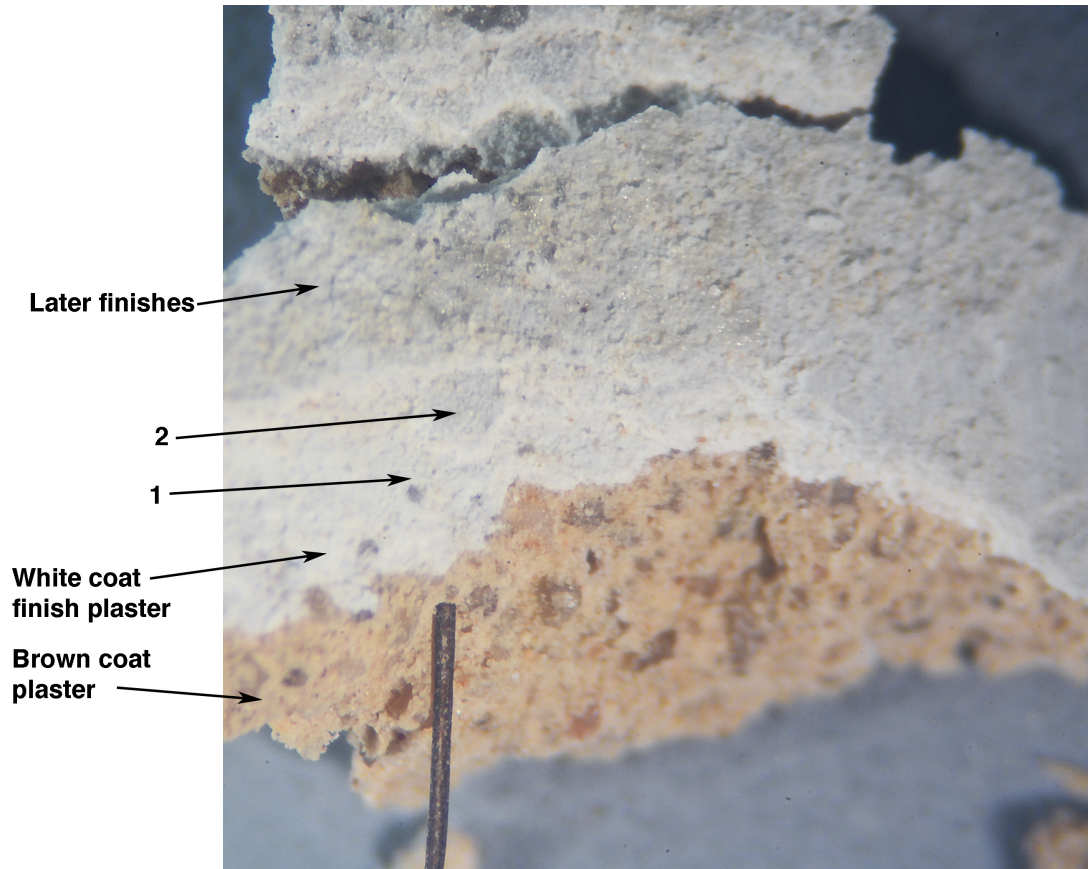
Note: The view of the sample is looking down onto the cross section. The brown coat [scratch coat] is clearly seen. Note that it supports a very thin white finish coat of plaster that is little more than a white wash. The white lime was a relatively expensive building material. There are two white wash layers on the surface of the ceiling plaster [1,2] that are the same lime coating in color. Both layers 1 and 2 may predate the sale of the building in 1914.

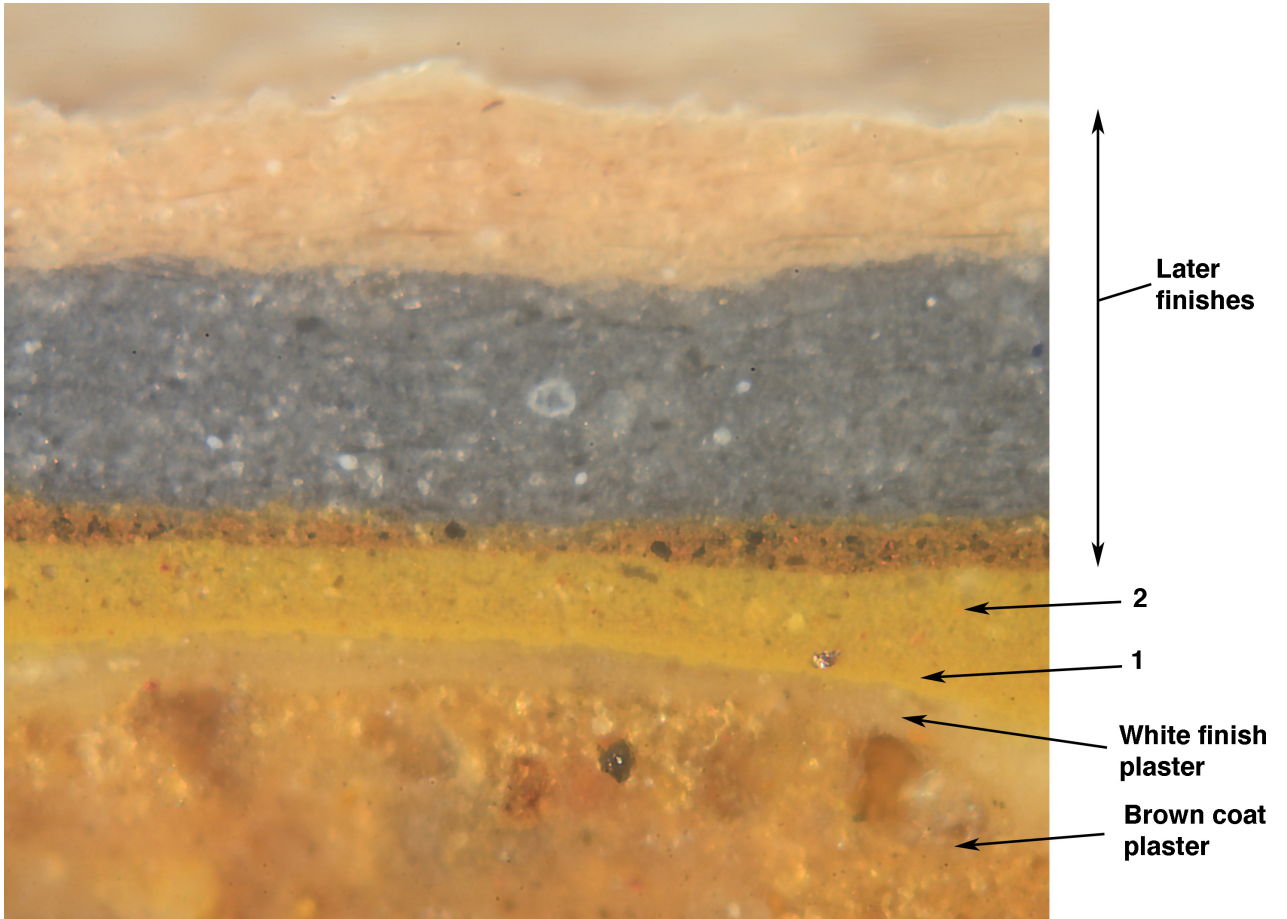
Note: The sample has been mounted in polymer resin, cut and polished to 8000 micron grit polishing cloth for additional examination. The brown [scratch] coat is clearly seen, and there is a very thin white finish plaster layer, also noted. The first paint coating is the first yellow ochre distemper finish [1], there is a second application of the same color, which appears to represent a second finish period [2]. The later finishes are also seen.

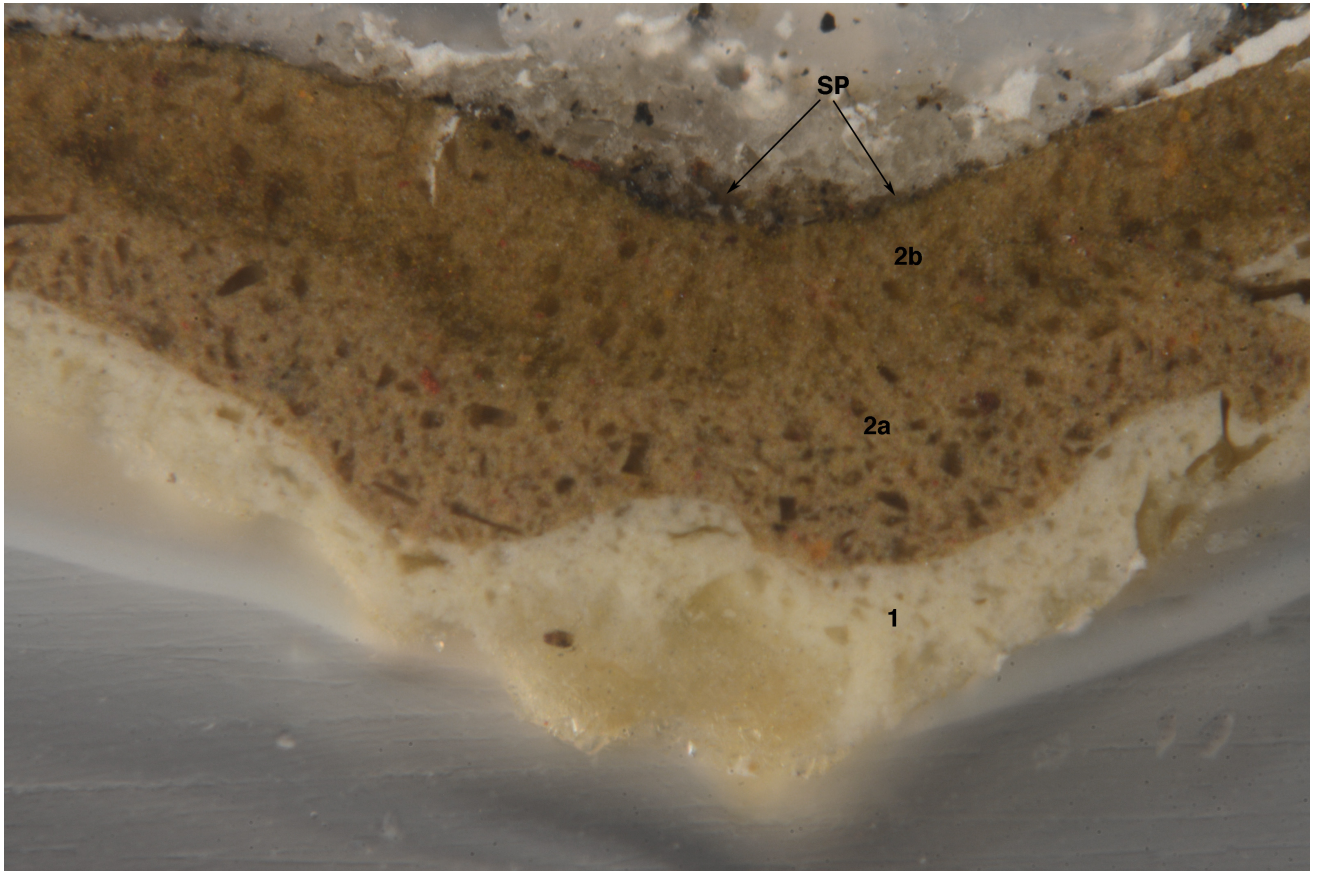
Note: The sample has been mounted in polymer resin, cut and polished to 8000 micron grit polishing cloth for additional examination. The paint layers have delaminated from the wood substrate. The first finish is the grayish white finish seen on the exterior as well [1]. This is followed by the moderate brown second finish [2a, 2b]. Note the very heavy surface particulate on the surface of the brown finish coat, 2b. This finish was exposed for a long period of time probably after ca. 1914.
